Access Compliance Report

Public Rights-of-Way

(Curb Ramps)

Intersection ID: 23662	Main Street: CARMEL_RD	Cross Street: RED_OAK_LN	Location: SE
ADA ID: 3F2C6136793D	Ramp Type: PerpDiag	Initial Pass/Fail: Fail	Overall Compliance: No
		Severity Score: 12.5

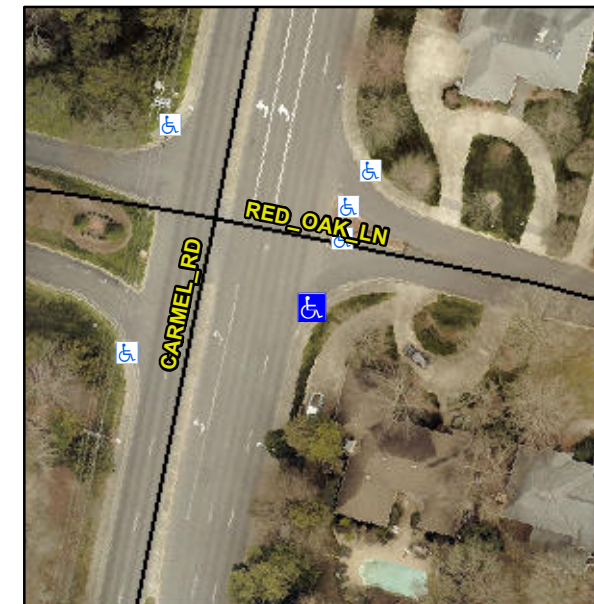
Compliance	Description	Data	Compliance	Description	Data
N/A	Ramp Length (in)	59.5	Yes	Ramp Slope (%)	7.9
Yes	Ramp Width (in)	77.0	No	Ramp XSlope (%)	5.1
N/A	Flare Type LT	N/A	N/A	Flare Type RT	N/A
N/A	Flare Slope LT (%)	N/A	N/A	Flare Slope RT (%)	N/A
N/A	Flare Traversable LT?	N/A	N/A	Flare Traversable RT?	N/A
N/A	Landing Length (in)	N/A	N/A	DWS Provided?	N/A
N/A	Landing Width (in)	N/A	N/A	DWS Contrast?	N/A
N/A	Landing Slope (%)	N/A	N/A	DWS Length (in)	N/A
N/A	Landing X Slope (%)	N/A	N/A	DWS Full Width?	N/A
N/A	Landing Curb? (Y/N)	N/A	N/A	DWS Offset (in)	N/A
N/A	Shared Landing?	N/A			
N/A	Gutter Ponding?	N/A	N/A	Gutter Slope (%)	N/A
N/A	Gutter Lip Ht (in)	N/A	N/A	Gutter X Slope (%)	N/A
N/A	Painted X Walk1?	No	N/A	Painted X Walk2?	No
	X Walk 1 Direction	To NE		X Walk 2 Direction	To NW
N/A	X Walk 1 Width (in)	N/A	N/A	X Walk 2 Width (in)	N/A
	X Walk 1 Slope (%)	0.9		X Walk 2 Slope (%)	4.2
	X Walk 1 X Slope (%)	6.6		X Walk 2 X Slope (%)	1.4

N/A	Ramp inside XWalk1?	N/A	N/A	Ramp inside XWalk2?	N/A
	Road Slope (%)	4.5	N/A	Clear Space?	N/A
	Road X Slope (%)	6.3	N/A	Clear Space to XWalk (in)	N/A
N/A	Any Obstructions?	N/A	N/A	Storm Grate/Utility Hazard?	N/A
	Obstruction Type			Storm Grate/Utility Type	
		N/A			N/A
			Yes	Surface Condition? (G/P)	Good

Remove & Replace Curb Ramp With Two New Directional Ramps or Equivalent.
