# Access Compliance Report

## Public Rights-of-Way

### (Curb Ramps)

Intersection ID: 49383	Main Street: CORRIENTE_CT	Cross Street: SOUTH_DEVON_ST	Location: E
ADA ID: 3F3393747A43	Ramp Type: PerpDiag	Initial Pass/Fail: Fail	Overall Compliance: No
		Severity Score: 12.5

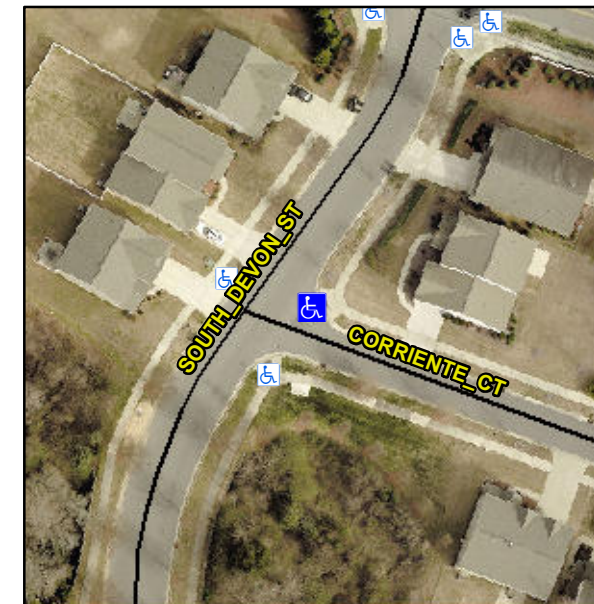
**Not Found, R304.2.2**

Compliance	Description	Data	Compliance	Description	Data
N/A	Ramp Length (in)	84.5	No	Ramp Slope (%)	10.5
Yes	Ramp Width (in)	48.0	Yes	Ramp XSlope (%)	1.8
N/A	Flare Type LT	N/A	N/A	Flare Type RT	N/A
N/A	Flare Slope LT (%)	N/A	N/A	Flare Slope RT (%)	N/A
N/A	Flare Traversable LT?	N/A	N/A	Flare Traversable RT?	N/A
N/A	Landing Length (in)	N/A	N/A	DWS Provided?	N/A
N/A	Landing Width (in)	N/A	N/A	DWS Contrast?	N/A
N/A	Landing Slope (%)	N/A	N/A	DWS Length (in)	N/A
N/A	Landing X Slope (%)	N/A	N/A	DWS Full Width?	N/A
N/A	Landing Curb? (Y/N)	N/A	N/A	DWS Offset (in)	N/A
N/A	Shared Landing?	N/A			
N/A	Gutter Ponding?	N/A	N/A	Gutter Slope (%)	N/A
N/A	Gutter Lip Ht (in)	N/A	N/A	Gutter X Slope (%)	N/A
N/A	Painted X Walk1?	No	N/A	Painted X Walk2?	No
	X Walk 1 Direction	To NW		X Walk 2 Direction	To SW
N/A	X Walk 1 Width (in)	N/A	N/A	X Walk 2 Width (in)	N/A
	X Walk 1 Slope (%)	0.9		X Walk 2 Slope (%)	1.1
	X Walk 1 X Slope (%)	1.0		X Walk 2 X Slope (%)	3.2

N/A	Ramp inside XWalk1?	N/A	N/A	Ramp inside XWalk2?	N/A
	Road Slope (%)	2.3	N/A	Clear Space?	N/A
	Road X Slope (%)	0.7	N/A	Clear Space to XWalk (in)	N/A
N/A	Any Obstructions?	N/A	N/A	Storm Grate/Utility Hazard?	N/A
	Obstruction Type			Storm Grate/Utility Type	
		N/A			N/A
			Yes	Surface Condition? (G/P)	Good

**Remove & Replace Curb Ramp With Two New Directional Ramps or Equivalent.**

Total Cost: \$ 3200.00
