Access Compliance Report

Public Rights-of-Way

(Curb Ramps)

Intersection ID: 8876	Main Street: ENNIS_AV	Cross Street: N_GRAHAM_ST	Location: E
ADA ID: 3F3B26CA079E	Ramp Type: Perp	Initial Pass/Fail: Fail	Overall Compliance: No
Severity Score: 13.75			
Codes/Mitigation Info/Possible Solution		Field Measurements/Component Compliance

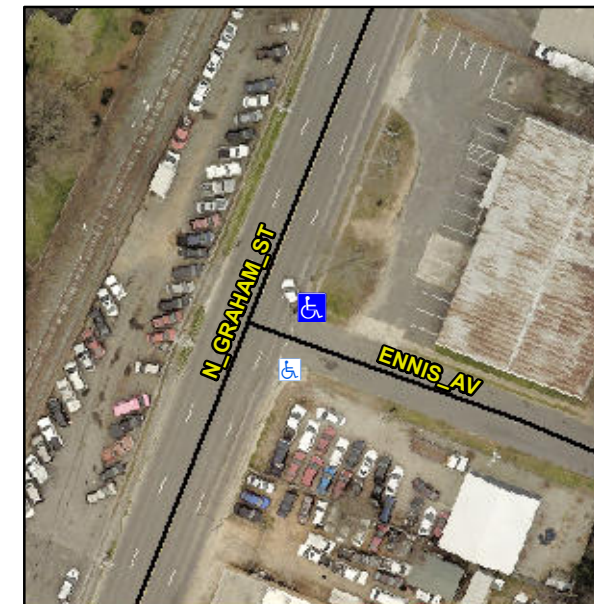
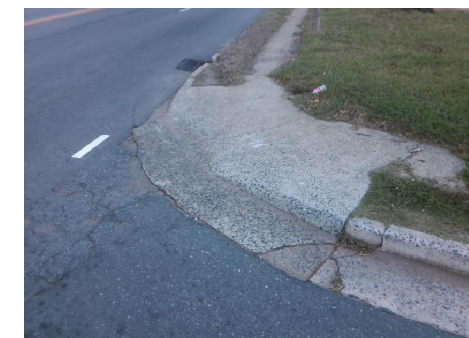
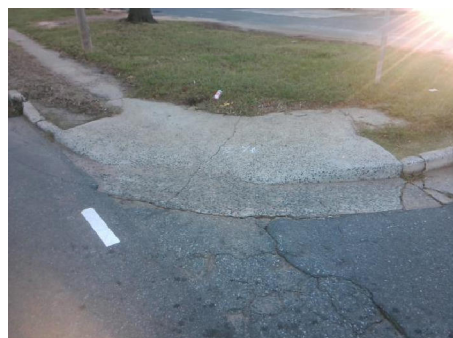
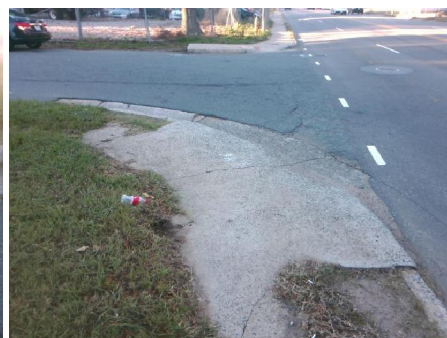
R304.2.2, R304.5.3

Compliance	Description	Data	Compliance	Description	Data
N/A	Ramp Length (in)	75.0	No	Ramp Slope (%)	10.2
Yes	Ramp Width (in)	61.0	No	Ramp XSlope (%)	4.6
N/A	Flare Type LT	N/A	N/A	Flare Type RT	N/A
N/A	Flare Slope LT (%)	N/A	N/A	Flare Slope RT (%)	N/A
N/A	Flare Traversable LT?	N/A	N/A	Flare Traversable RT?	N/A
N/A	Landing Length (in)	N/A	N/A	DWS Provided?	N/A
N/A	Landing Width (in)	N/A	N/A	DWS Contrast?	N/A
N/A	Landing Slope (%)	N/A	N/A	DWS Length (in)	N/A
N/A	Landing X Slope (%)	N/A	N/A	DWS Full Width?	N/A
N/A	Landing Curb? (Y/N)	N/A	N/A	DWS Offset (in)	N/A
N/A	Shared Landing?	N/A			
N/A	Gutter Ponding?	N/A	N/A	Gutter Slope (%)	N/A
N/A	Gutter Lip Ht (in)	0.5	N/A	Gutter X Slope (%)	N/A
N/A	Painted X Walk1?	No	N/A	Painted X Walk2?	N/A
	X Walk 1 Direction	To SW		X Walk 2 Direction	N/A
N/A	X Walk 1 Width (in)	N/A	N/A	X Walk 2 Width (in)	N/A
	X Walk 1 Slope (%)	0.3		X Walk 2 Slope (%)	N/A
	X Walk 1 X Slope (%)	4.5		X Walk 2 X Slope (%)	N/A

N/A	Ramp inside XWalk1?	N/A	N/A	Ramp inside XWalk2?	N/A
	Road Slope (%)	N/A	N/A	Clear Space?	N/A
	Road X Slope (%)	N/A	N/A	Clear Space to XWalk (in)	N/A
N/A	Any Obstructions?	N/A	N/A	Storm Grate/Utility Hazard?	N/A
	Obstruction Type			Storm Grate/Utility Type	
		N/A			N/A
		Yes		Surface Condition? (G/P)	Good

Remove & Replace Entire Ramp.

\$ 1850.00
