# Access Compliance Report

## Public Rights-of-Way

### (Curb Ramps)

Intersection ID: 8515	Main Street: ATANDO_AV	Cross Street: STATESVILLE_AV	Location: NE
ADA ID: 3F3D9DC7B6C3	Ramp Type: Combination1	Initial Pass/Fail: Fail	Overall Compliance: No
			Severity Score: 18.75

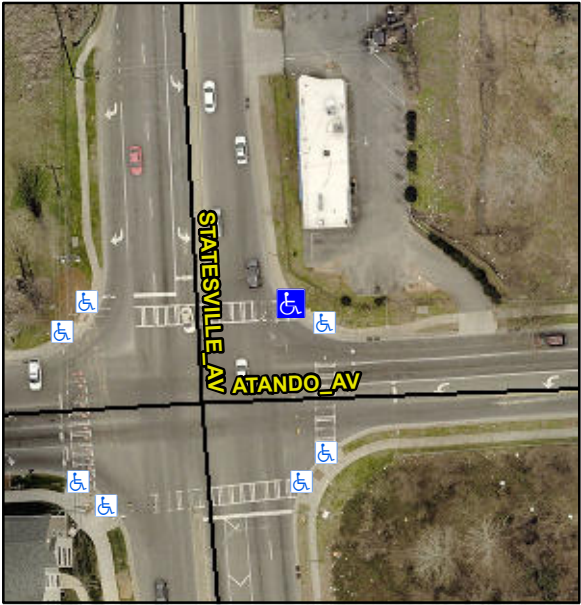
Possible Solutions:		<b>Compliance</b>	<b>Description</b>	<b>Data</b>
	<b>Remove &amp; Replace Entire Ramp.</b>		<b>N/A</b>	Ramp Length LT (in)	<b>64.0</b>
			<b>No</b>	Ramp Width LT (in)	<b>33.0</b>
			<b>Yes</b>	Ramp Slope LT (%)	<b>5.7</b>
			<b>No</b>	Ramp XSlope LT (%)	<b>3.7</b>
			<b>N/A</b>	Ramp Length (in)	<b>26.0</b>
			<b>No</b>	Ramp Width (in)	<b>45.0</b>
	Surveyor Notes:		<b>N/A</b>	Flare Type LT	<b>N/A</b>
	<b>N/A</b>		<b>N/A</b>	Flare Slope LT (%)	<b>N/A</b>
			<b>N/A</b>	Flare Traversable LT?	<b>N/A</b>
	PROW/ADA:		<b>N/A</b>	Landing Length (in)	<b>N/A</b>
	<b>R304.5.1, R304.5.1, R304.5.3</b>		<b>N/A</b>	Landing Width (in)	<b>N/A</b>
			<b>N/A</b>	Landing Slope (%)	<b>N/A</b>
			<b>N/A</b>	Landing X Slope (%)	<b>N/A</b>
			<b>N/A</b>	Landing Curb? (Y/N)	<b>N/A</b>
			<b>N/A</b>	Shared Landing?	<b>N/A</b>

<b>N/A</b>	Gutter Ponding?	<b>N/A</b>
			<b>N/A</b>	Gutter Lip Ht (in)	<b>N/A</b>
			<b>N/A</b>	Painted X Walk1?	<b>Yes</b>
				X Walk 1 Direction	<b>To W</b>
				X Walk 1 Width (in)	<b>118.0</b>
				X Walk 1 Slope (%)	<b>0.2</b>
				X Walk 1 X Slope (%)	<b>2.3</b>
	Total Cost:	<b>\$ 1800.00</b>	<b>N/A</b>	Ramp inside XWalk1?	<b>Yes</b>
				Road Slope (%)	<b>N/A</b>
				Road X Slope (%)	<b>N/A</b>
				Clear Space?	<b>N/A</b>
				Clear Space to XWalk (in)	<b>N/A</b>
				Any Obstruction?	<b>N/A</b>
				Obstruction Type	<b>N/A</b>

Storm Grate/Utility Hazard?	<b>N/A</b>
				Storm Grate/Utility Type	<b>N/A</b>
					<b>N/A</b>
			<b>Yes</b>	Surface Condition? (G/P)	<b>Good</b>
				Curb Slope (%)	<b>3.4</b>
