Access Compliance Report

Public Rights-of-Way

(Curb Ramps)

Intersection ID: 2832	Main Street: GOLDENFIELD_DR	Cross Street: DEARVIEW_LN	Location:	N
ADA ID: 3F508A1D3406	Ramp Type: Perp	Initial Pass/Fail: Fail	Overall Compliance: No	Severity Score: 10

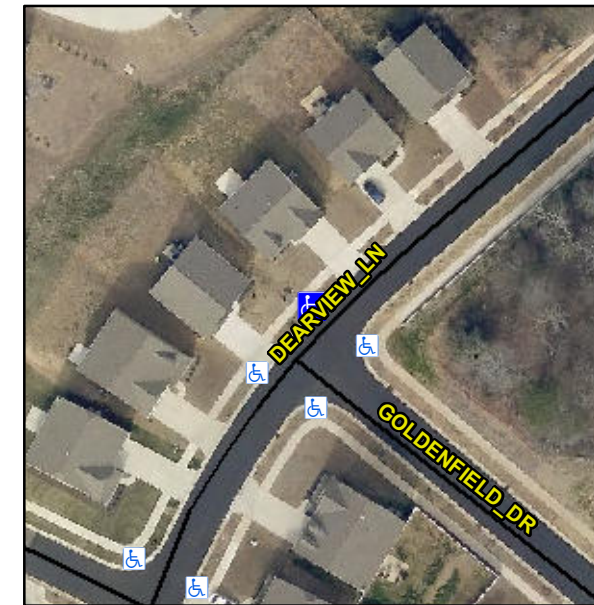
Not Found, R304.5.1, R304.5.3

Compliance	Description	Data	Compliance	Description	Data
N/A	Ramp Length (in)	69.0	Yes	Ramp Slope (%)	8.1
No	Ramp Width (in)	47.5	No	Ramp XSlope (%)	4.6
N/A	Flare Type LT	N/A	N/A	Flare Type RT	N/A
N/A	Flare Slope LT (%)	N/A	N/A	Flare Slope RT (%)	N/A
N/A	Flare Traversable LT?	N/A	N/A	Flare Traversable RT?	N/A
N/A	Landing Length (in)	N/A	N/A	DWS Provided?	N/A
N/A	Landing Width (in)	N/A	N/A	DWS Contrast?	N/A
N/A	Landing Slope (%)	N/A	N/A	DWS Length (in)	N/A
N/A	Landing X Slope (%)	N/A	N/A	DWS Full Width?	N/A
N/A	Landing Curb? (Y/N)	N/A	N/A	DWS Offset (in)	N/A
N/A	Shared Landing?	N/A			
N/A	Gutter Ponding?	N/A	N/A	Gutter Slope (%)	N/A
N/A	Gutter Lip Ht (in)	N/A	N/A	Gutter X Slope (%)	N/A
N/A	Painted X Walk1?	No	N/A	Painted X Walk2?	N/A
	X Walk 1 Direction	To SE		X Walk 2 Direction	N/A
N/A	X Walk 1 Width (in)	N/A	N/A	X Walk 2 Width (in)	N/A
	X Walk 1 Slope (%)	4.3		X Walk 2 Slope (%)	N/A
	X Walk 1 X Slope (%)	2.3		X Walk 2 X Slope (%)	N/A

N/A	Ramp inside XWalk1?	N/A	N/A	Ramp inside XWalk2?	N/A
	Road Slope (%)	N/A	N/A	Clear Space?	N/A
	Road X Slope (%)	N/A	N/A	Clear Space to XWalk (in)	N/A
N/A	Any Obstructions?	N/A	N/A	Storm Grate/Utility Hazard?	N/A
	Obstruction Type			Storm Grate/Utility Type	
		N/A			N/A
			Yes	Surface Condition? (G/P)	Good

Remove & Replace Entire Ramp.
