Access Compliance Report

Public Rights-of-Way

(Curb Ramps)

Intersection ID: 3874	Main Street: GARRISON_RD	Cross Street: MARBLE_HILL_DR	Location: W
ADA ID: 3F5B024E2483	Ramp Type: PerpDiag	Initial Pass/Fail: Fail	Overall Compliance: No
		Severity Score: 30

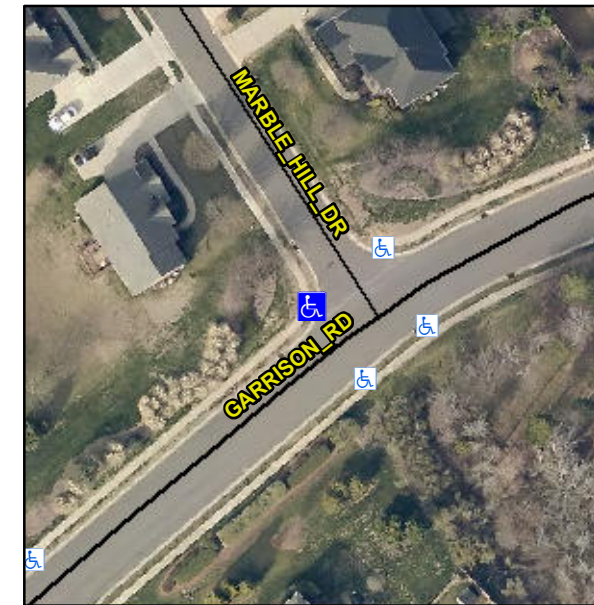
Not Found, R304.5.1, R304.2.2

Compliance	Description	Data	Compliance	Description	Data
N/A	Ramp Length (in)	46.5	No	Ramp Slope (%)	8.5
No	Ramp Width (in)	35.0	Yes	Ramp XSlope (%)	1.8
N/A	Flare Type LT	N/A	N/A	Flare Type RT	N/A
N/A	Flare Slope LT (%)	N/A	N/A	Flare Slope RT (%)	N/A
N/A	Flare Traversable LT?	N/A	N/A	Flare Traversable RT?	N/A
N/A	Landing Length (in)	N/A	N/A	DWS Provided?	N/A
N/A	Landing Width (in)	N/A	N/A	DWS Contrast?	N/A
N/A	Landing Slope (%)	N/A	N/A	DWS Length (in)	N/A
N/A	Landing X Slope (%)	N/A	N/A	DWS Full Width?	N/A
N/A	Landing Curb? (Y/N)	N/A	N/A	DWS Offset (in)	N/A
N/A	Shared Landing?	N/A			
N/A	Gutter Ponding?	N/A	N/A	Gutter Slope (%)	N/A
N/A	Gutter Lip Ht (in)	N/A	N/A	Gutter X Slope (%)	N/A
N/A	Painted X Walk1?	No	N/A	Painted X Walk2?	No
	X Walk 1 Direction	To SE		X Walk 2 Direction	To NE
N/A	X Walk 1 Width (in)	N/A	N/A	X Walk 2 Width (in)	N/A
	X Walk 1 Slope (%)	1.8		X Walk 2 Slope (%)	1.2
	X Walk 1 X Slope (%)	0.9		X Walk 2 X Slope (%)	0.2

N/A	Ramp inside XWalk1?	N/A	N/A	Ramp inside XWalk2?	N/A
	Road Slope (%)	0.1	N/A	Clear Space?	N/A
	Road X Slope (%)	1.2	N/A	Clear Space to XWalk (in)	N/A
N/A	Any Obstructions?	N/A	N/A	Storm Grate/Utility Hazard?	N/A
	Obstruction Type			Storm Grate/Utility Type	
		N/A			N/A
			Yes	Surface Condition? (G/P)	Good

Remove & Replace Curb Ramp With Two New Directional Ramps or Equivalent.
