Access Compliance Report

Public Rights-of-Way

(Curb Ramps)

Intersection ID: 19542	Main Street: PROVIDENCE_RD	Cross Street: STRAWBERRY_HILL_DR	Location: E
ADA ID: 3F6DE8EAFCC2	Ramp Type: PerpDiag	Initial Pass/Fail: Fail	Overall Compliance: No
Codes/Mitigation Info/Possible Solution		Field Measurements/Component Compliance	
Severity Score: 26.25

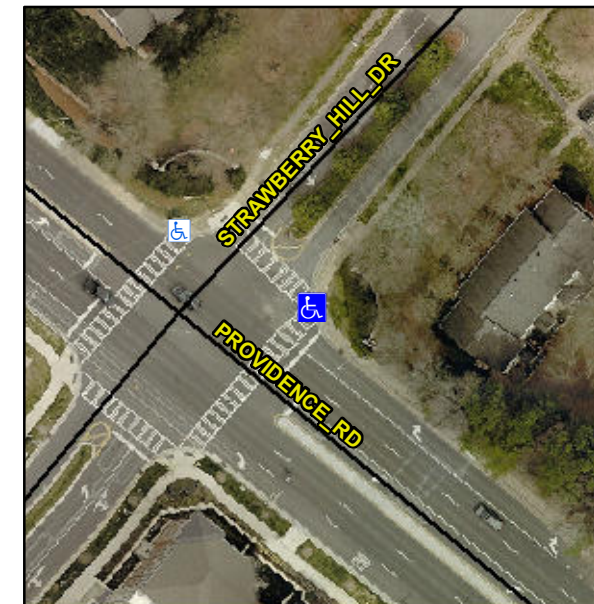
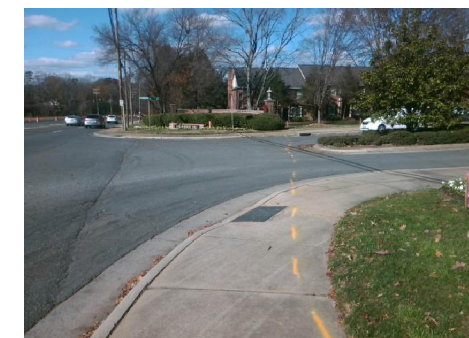
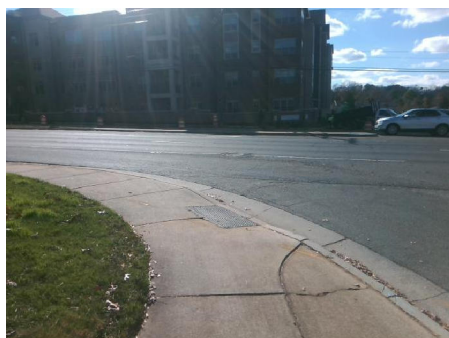
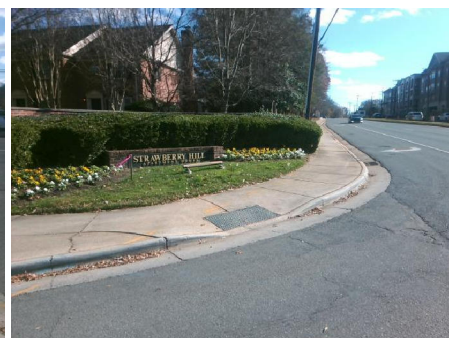
Not Found, R304.2.2, R304.5.3

Compliance	Description	Data	Compliance	Description	Data
N/A	Ramp Length (in)	73.0	No	Ramp Slope (%)	12.8
Yes	Ramp Width (in)	48.0	No	Ramp XSlope (%)	4.6
N/A	Flare Type LT	N/A	N/A	Flare Type RT	N/A
N/A	Flare Slope LT (%)	N/A	N/A	Flare Slope RT (%)	N/A
N/A	Flare Traversable LT?	N/A	N/A	Flare Traversable RT?	N/A
N/A	Landing Length (in)	N/A	N/A	DWS Provided?	N/A
N/A	Landing Width (in)	N/A	N/A	DWS Contrast?	N/A
N/A	Landing Slope (%)	N/A	N/A	DWS Length (in)	N/A
N/A	Landing X Slope (%)	N/A	N/A	DWS Full Width?	N/A
N/A	Landing Curb? (Y/N)	N/A	N/A	DWS Offset (in)	N/A
N/A	Shared Landing?	N/A			
N/A	Gutter Ponding?	N/A	N/A	Gutter Slope (%)	N/A
N/A	Gutter Lip Ht (in)	N/A	N/A	Gutter X Slope (%)	N/A
N/A	Painted X Walk1?	No	N/A	Painted X Walk2?	No
	X Walk 1 Direction	To NW		X Walk 2 Direction	To SW
N/A	X Walk 1 Width (in)	N/A	N/A	X Walk 2 Width (in)	N/A
	X Walk 1 Slope (%)	1.2		X Walk 2 Slope (%)	3.9
	X Walk 1 X Slope (%)	3.2		X Walk 2 X Slope (%)	0.7

N/A	Ramp inside XWalk1?	N/A	N/A	Ramp inside XWalk2?	N/A
	Road Slope (%)	3.1	N/A	Clear Space?	N/A
	Road X Slope (%)	1.8	N/A	Clear Space to XWalk (in)	N/A
N/A	Any Obstructions?	N/A	N/A	Storm Grate/Utility Hazard?	N/A
	Obstruction Type			Storm Grate/Utility Type	
		N/A			N/A
			Yes	Surface Condition? (G/P)	Good

Remove & Replace Curb Ramp With Two New Directional Ramps or Equivalent.
