Access Compliance Report

Public Rights-of-Way

(Curb Ramps)

Intersection ID: 42756	Main Street: CALDWELL_FOREST_DR	Cross Street: CALDWELL_RIDGE_PY	Location:	N
ADA ID: 3F6F70BA7860	Ramp Type: PerpDiag	Initial Pass/Fail: Fail	Overall Compliance: No	Severity Score: 13.75

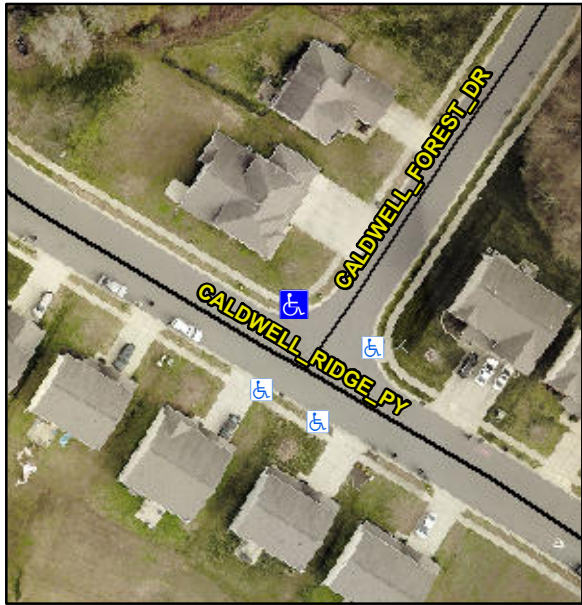
Compliance			Description			Data			Compliance			Description			Data		
N/A			Ramp Length (in)			57.0			No			Ramp Slope (%)			10.1		
Yes			Ramp Width (in)			50.5			No			Ramp XSlope (%)			4.6		
N/A			Flare Type LT			N/A			N/A			Flare Type RT			N/A		
N/A			Flare Slope LT (%)			N/A			N/A			Flare Slope RT (%)			N/A		
N/A			Flare Traversable LT?			N/A			N/A			Flare Traversable RT?			N/A		
N/A			Landing Length (in)			N/A			N/A			DWS Provided?			N/A		
N/A			Landing Width (in)			N/A			N/A			DWS Contrast?			N/A		
N/A			Landing Slope (%)			N/A			N/A			DWS Length (in)			N/A		
N/A			Landing X Slope (%)			N/A			N/A			DWS Full Width?			N/A		
N/A			Landing Curb? (Y/N)			N/A			N/A			DWS Offset (in)			N/A		
N/A			Shared Landing?			N/A											
N/A			Gutter Ponding?			N/A			N/A			Gutter Slope (%)			N/A		
N/A			Gutter Lip Ht (in)			N/A			N/A			Gutter X Slope (%)			N/A		
N/A			Painted X Walk1?			No			N/A			Painted X Walk2?			No

X Walk 1 Direction			To SW						X Walk 2 Direction			To SE		
N/A			X Walk 1 Width (in)			N/A			N/A			X Walk 2 Width (in)			N/A		
			X Walk 1 Slope (%)			3.8						X Walk 2 Slope (%)			7.2		
			X Walk 1 X Slope (%)			6.4						X Walk 2 X Slope (%)			0.3		
N/A			Ramp inside XWalk1?			N/A			N/A			Ramp inside XWalk2?			N/A		
			Road Slope (%)			3.6			N/A			Clear Space?			N/A		
			Road X Slope (%)			6.0			N/A			Clear Space to XWalk (in)			N/A		
N/A			Any Obstructions?			N/A			N/A			Storm Grate/Utility Hazard?			N/A		
			Obstruction Type									Storm Grate/Utility Type					
									N/A						N/A		
									Yes			Surface Condition? (G/P)			Good

<div>Street 1 Name Stop Condition-Street 2 Street 2 Name Stop Condition-Street 1</div>	Possible Solutions:		Compliance			Compliance		
	Remove & Replace Curb Ramp With Two New Directional Ramps or Equivalent.		Description			Description		
			Data			Data		
			N/A			No		
			Yes			No		
			N/A			N/A		
			N/A			N/A		
			N/A			N/A		
			N/A			N/A		
			N/A			N/A		
Surveyor Notes:								
N/A								
PROW/ADA:								
Not Found, R304.2.2, R304.5.3								
Total Cost:		\$ 3200.00
