Access Compliance Report

Public Rights-of-Way

(Curb Ramps)

Intersection ID: 46529	Main Street: BEAVER_CREEK_DR	Cross Street: PROSPERITY_CHURCH_RD	Location: SE
ADA ID: 3F72419FE1C7	Ramp Type: Perp	Initial Pass/Fail: Fail	Overall Compliance: No
Severity Score: 8.75			
Codes/Mitigation Info/Possible Solution		Field Measurements/Component Compliance

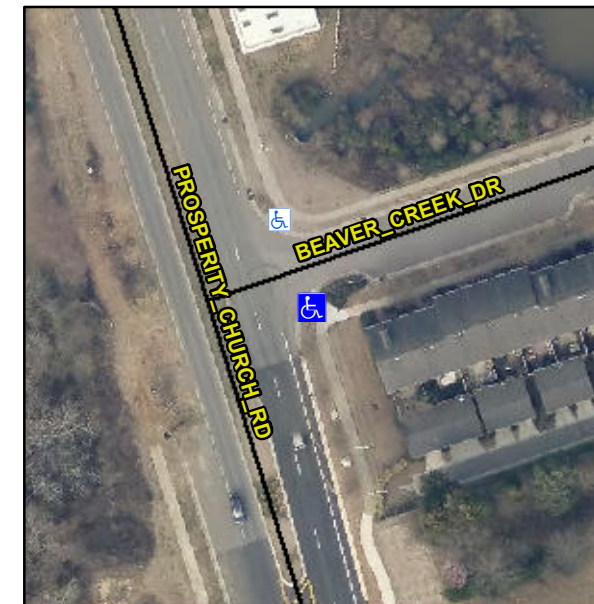
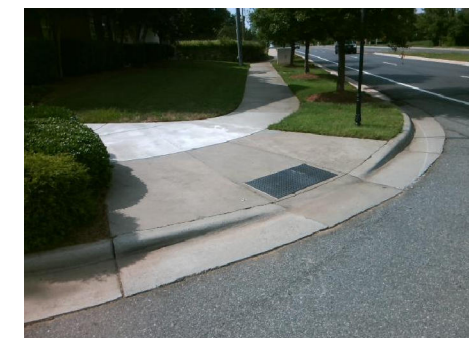
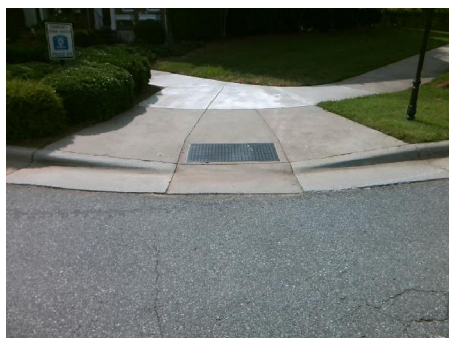
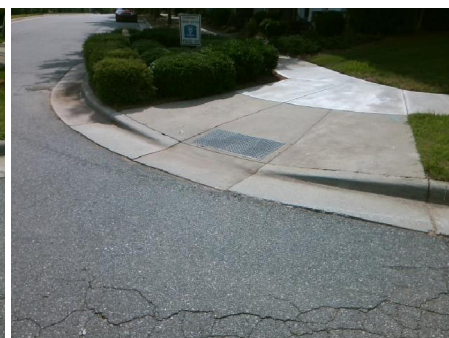
Compliance	Description	Data	Compliance	Description	Data
N/A	Ramp Length (in)	97.0	Yes	Ramp Slope (%)	5.5
No	Ramp Width (in)	38.0	Yes	Ramp XSlope (%)	1.4
N/A	Flare Type LT	N/A	N/A	Flare Type RT	N/A
N/A	Flare Slope LT (%)	N/A	N/A	Flare Slope RT (%)	N/A
N/A	Flare Traversable LT?	N/A	N/A	Flare Traversable RT?	N/A
N/A	Landing Length (in)	N/A	N/A	DWS Provided?	N/A
N/A	Landing Width (in)	N/A	N/A	DWS Contrast?	N/A
N/A	Landing Slope (%)	N/A	N/A	DWS Length (in)	N/A
N/A	Landing X Slope (%)	N/A	N/A	DWS Full Width?	N/A
N/A	Landing Curb? (Y/N)	N/A	N/A	DWS Offset (in)	N/A
N/A	Shared Landing?	N/A			
N/A	Gutter Ponding?	N/A	N/A	Gutter Slope (%)	N/A
N/A	Gutter Lip Ht (in)	N/A	N/A	Gutter X Slope (%)	N/A
N/A	Painted X Walk1?	No	N/A	Painted X Walk2?	N/A
	X Walk 1 Direction	To N		X Walk 2 Direction	N/A
N/A	X Walk 1 Width (in)	N/A	N/A	X Walk 2 Width (in)	N/A
	X Walk 1 Slope (%)	2.2		X Walk 2 Slope (%)	N/A
	X Walk 1 X Slope (%)	1.1		X Walk 2 X Slope (%)	N/A

N/A	Ramp inside XWalk1?	N/A	N/A	Ramp inside XWalk2?	N/A
	Road Slope (%)	N/A	N/A	Clear Space?	N/A
	Road X Slope (%)	N/A	N/A	Clear Space to XWalk (in)	N/A
N/A	Any Obstructions?	N/A	N/A	Storm Grate/Utility Hazard?	N/A
	Obstruction Type			Storm Grate/Utility Type	
		N/A			N/A
		Yes		Surface Condition? (G/P)	Good

Possible Solutions:

Remove & Replace Entire Ramp.

R304.5.1
