Access Compliance Report

Public Rights-of-Way

(Curb Ramps)

Intersection ID: 31313	Main Street: DEERTON_RD	Cross Street: EBEN_DR	Location:	W
ADA ID: 3F7AF6D97CD7	Ramp Type: PerpDiag	Initial Pass/Fail: Fail	Overall Compliance: No	Severity Score: 10
Codes/Mitigation Info/Possible Solution		Field Measurements/Component Compliance

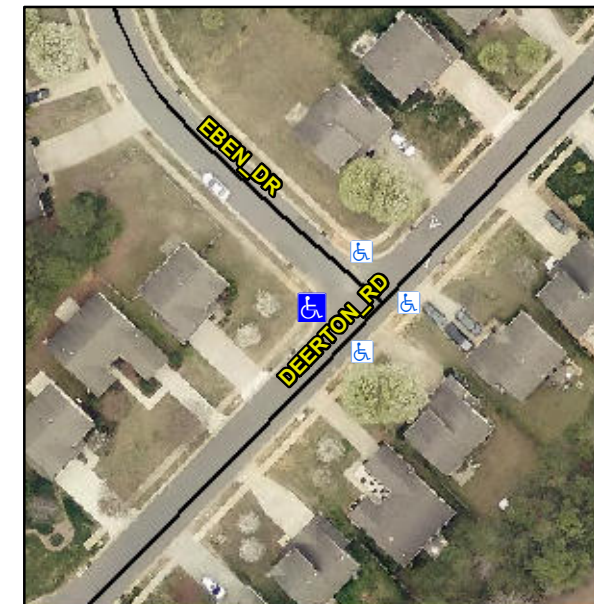
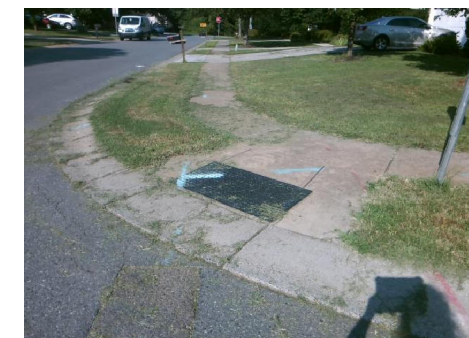
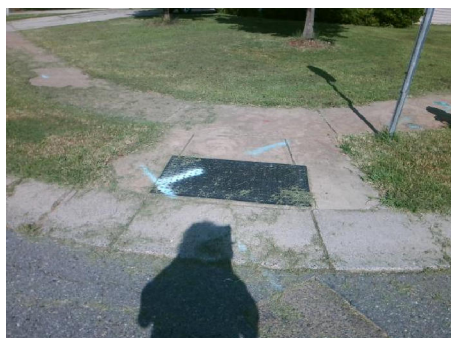
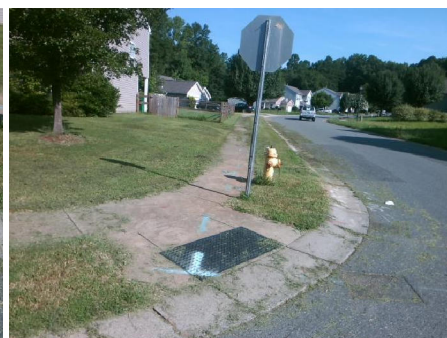
R304.5.1, R304.5.3

Compliance	Description	Data	Compliance	Description	Data
N/A	Ramp Length (in)	50.0	Yes	Ramp Slope (%)	7.1
No	Ramp Width (in)	37.0	No	Ramp XSlope (%)	3.0
N/A	Flare Type LT	N/A	N/A	Flare Type RT	N/A
N/A	Flare Slope LT (%)	N/A	N/A	Flare Slope RT (%)	N/A
N/A	Flare Traversable LT?	N/A	N/A	Flare Traversable RT?	N/A
N/A	Landing Length (in)	N/A	N/A	DWS Provided?	N/A
N/A	Landing Width (in)	N/A	N/A	DWS Contrast?	N/A
N/A	Landing Slope (%)	N/A	N/A	DWS Length (in)	N/A
N/A	Landing X Slope (%)	N/A	N/A	DWS Full Width?	N/A
N/A	Landing Curb? (Y/N)	N/A	N/A	DWS Offset (in)	N/A
N/A	Shared Landing?	N/A			
N/A	Gutter Ponding?	N/A	N/A	Gutter Slope (%)	N/A
N/A	Gutter Lip Ht (in)	N/A	N/A	Gutter X Slope (%)	N/A
N/A	Painted X Walk1?	No	N/A	Painted X Walk2?	No
	X Walk 1 Direction	To SE		X Walk 2 Direction	To NE
N/A	X Walk 1 Width (in)	N/A	N/A	X Walk 2 Width (in)	N/A
	X Walk 1 Slope (%)	0.9		X Walk 2 Slope (%)	1.4
	X Walk 1 X Slope (%)	1.2		X Walk 2 X Slope (%)	2.1

N/A	Ramp inside XWalk1?	N/A	N/A	Ramp inside XWalk2?	N/A
	Road Slope (%)	1.7	N/A	Clear Space?	N/A
	Road X Slope (%)	0.6	N/A	Clear Space to XWalk (in)	N/A
N/A	Any Obstructions?	N/A	N/A	Storm Grate/Utility Hazard?	N/A
	Obstruction Type			Storm Grate/Utility Type	
		N/A			N/A
			Yes	Surface Condition? (G/P)	Good

Remove & Replace Curb Ramp With Two New Directional Ramps or Equivalent.
