Access Compliance Report

Public Rights-of-Way

(Curb Ramps)

Intersection ID: 27333	Main Street: BALLANTYNE_MEDICAL_PL	Cross Street: BRIXHAM_HILL_AV	Location: NW
ADA ID: 3F88C7A5CAC5	Ramp Type: Perp	Initial Pass/Fail: Fail	Overall Compliance: No
Severity Score: 12.5			
Codes/Mitigation Info/Possible Solution		Field Measurements/Component Compliance

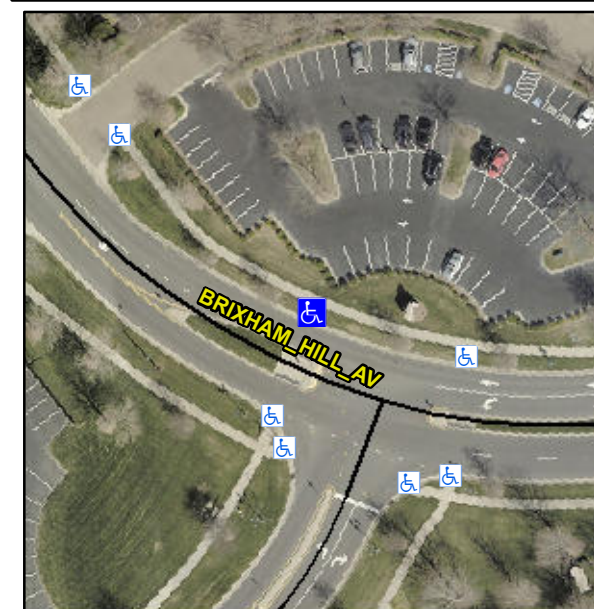
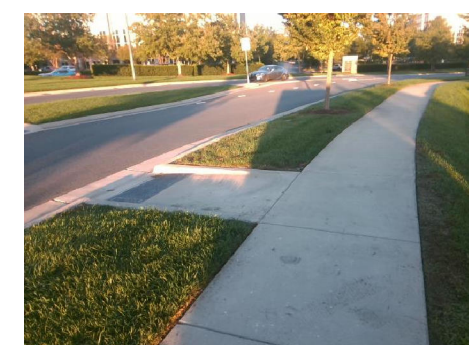
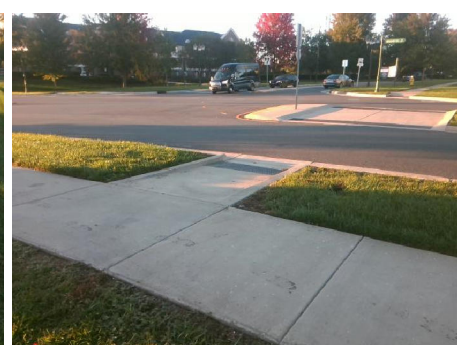
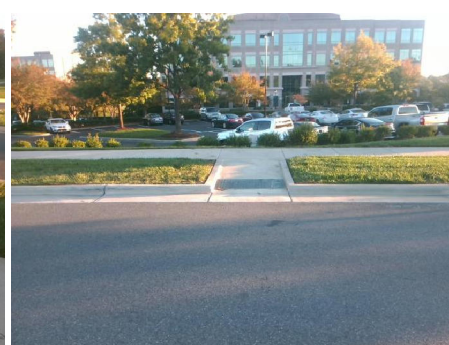
Not Found, R304.2.2

Compliance	Description	Data	Compliance	Description	Data
N/A	Ramp Length (in)	96.0	No	Ramp Slope (%)	10.3
Yes	Ramp Width (in)	57.0	Yes	Ramp XSlope (%)	0.3
N/A	Flare Type LT	N/A	N/A	Flare Type RT	N/A
N/A	Flare Slope LT (%)	N/A	N/A	Flare Slope RT (%)	N/A
N/A	Flare Traversable LT?	N/A	N/A	Flare Traversable RT?	N/A
N/A	Landing Length (in)	N/A	N/A	DWS Provided?	N/A
N/A	Landing Width (in)	N/A	N/A	DWS Contrast?	N/A
N/A	Landing Slope (%)	N/A	N/A	DWS Length (in)	N/A
N/A	Landing X Slope (%)	N/A	N/A	DWS Full Width?	N/A
N/A	Landing Curb? (Y/N)	N/A	N/A	DWS Offset (in)	N/A
N/A	Shared Landing?	N/A			
N/A	Gutter Ponding?	N/A	N/A	Gutter Slope (%)	N/A
N/A	Gutter Lip Ht (in)	N/A	N/A	Gutter X Slope (%)	N/A
N/A	Painted X Walk1?	No	N/A	Painted X Walk2?	N/A
	X Walk 1 Direction	To S		X Walk 2 Direction	N/A
N/A	X Walk 1 Width (in)	N/A	N/A	X Walk 2 Width (in)	N/A
	X Walk 1 Slope (%)	2.0		X Walk 2 Slope (%)	N/A
	X Walk 1 X Slope (%)	0.4		X Walk 2 X Slope (%)	N/A

N/A	Ramp inside XWalk1?	N/A	N/A	Ramp inside XWalk2?	N/A
	Road Slope (%)	N/A	N/A	Clear Space?	N/A
	Road X Slope (%)	N/A	N/A	Clear Space to XWalk (in)	N/A
N/A	Any Obstructions?	N/A	N/A	Storm Grate/Utility Hazard?	N/A
	Obstruction Type			Storm Grate/Utility Type	
		N/A			N/A
			Yes	Surface Condition? (G/P)	Good

Remove & Replace Entire Ramp.

Total Cost: \$ 1850.00
