# Access Compliance Report

## Public Rights-of-Way

### (Curb Ramps)

| Intersection ID: 48058 | Main Street: FERRELL_AV | Cross Street: KEENER_RIDGE_RD | Location: SE |

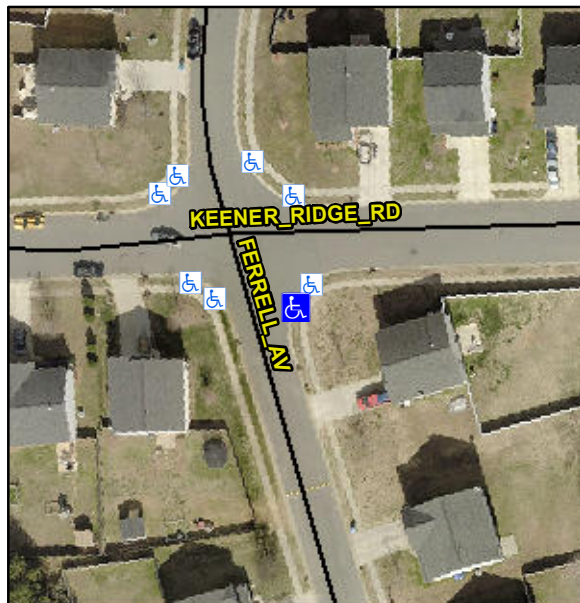
**Not Found, R304.5.3, R304.2.2-Perp,  
R304.3.2-Para, R304.5.4**

| Compliance | Description | Data | Compliance | Description | Data |
|---|---|---|---|---|---|
| Yes | Ramp Width (in) | 48.0 | No | Ramp XSlope (%) | 4.6 |
| No | Landing Slope (%) | 3.2 | Yes | DWS Length (in) | 25.0 |
| No | Landing X Slope (%) | 4.8 | Yes | DWS Full Width? | Yes |
| Yes | Gutter Ponding? | No | No | Gutter Slope (%) | 13.6 |
| Yes | Gutter Lip Ht (in) | 0.0 | No | Gutter X Slope (%) | 5.7 |

**Remove & Replace Entire Ramp.  
Remove & Replace Gutter.**
