Access Compliance Report Public Rights-of-Way (Curb Ramps)

Intersection ID: 10772 Main Street: E_36TH_ST Cross Street: THE_PLAZA Location: S

ADA ID: 3F98A1BC4DDD Ramp Type: PerpDiag Initial Pass/Fail: Fail Overall Compliance: No Severity Score: 13.75

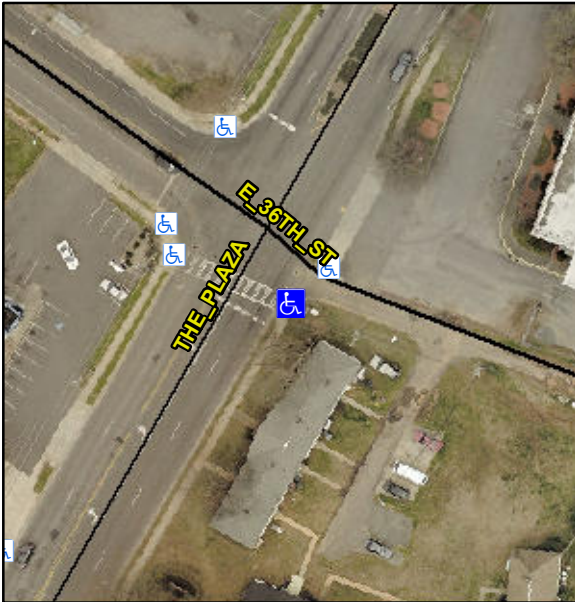
Compliance	Description	Data	Compliance	Description	Data
N/A	Ramp Length (in)	59.5	No	Ramp Slope (%)	8.8
Yes	Ramp Width (in)	58.0	No	Ramp XSlope (%)	3.1
N/A	Flare Type LT	N/A	N/A	Flare Type RT	N/A
N/A	Flare Slope LT (%)	N/A	N/A	Flare Slope RT (%)	N/A
N/A	Flare Traversable LT?	N/A	N/A	Flare Traversable RT?	N/A
N/A	Landing Length (in)	N/A	N/A	DWS Provided?	N/A
N/A	Landing Width (in)	N/A	N/A	DWS Contrast?	N/A
N/A	Landing Slope (%)	N/A	N/A	DWS Length (in)	N/A
N/A	Landing X Slope (%)	N/A	N/A	DWS Full Width?	N/A
N/A	Landing Curb? (Y/N)	N/A	N/A	DWS Offset (in)	N/A
N/A	Shared Landing?	N/A			
N/A	Gutter Ponding?	N/A	N/A	Gutter Slope (%)	N/A
N/A	Gutter Lip Ht (in)	N/A	N/A	Gutter X Slope (%)	N/A
N/A	Painted X Walk1?	No	N/A	Painted X Walk2?	Yes
	X Walk 1 Direction	To NE		X Walk 2 Direction	To NW
N/A	X Walk 1 Width (in)	N/A	N/A	X Walk 2 Width (in)	95.5
	X Walk 1 Slope (%)	2.0		X Walk 2 Slope (%)	0.8
	X Walk 1 X Slope (%)	0.8		X Walk 2 X Slope (%)	3.8

N/A	Ramp inside XWalk1?	N/A	N/A	Ramp inside XWalk2?	Yes
	Road Slope (%)	2.4	N/A	Clear Space?	N/A
	Road X Slope (%)	3.9	N/A	Clear Space to XWalk (in)	N/A
N/A	Any Obstructions?	N/A	N/A	Storm Grate/Utility Hazard?	N/A
	Obstruction Type			Storm Grate/Utility Type	
		N/A			N/A
Yes	Surface Condition? (G/P)				Good

Remove & Replace Curb Ramp With Two New Directional Ramps or Equivalent.

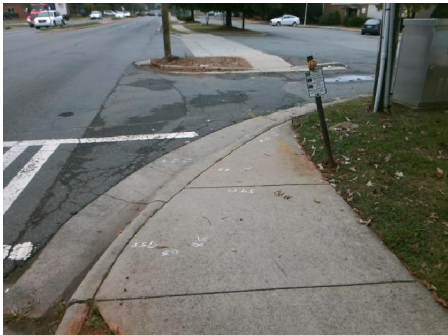
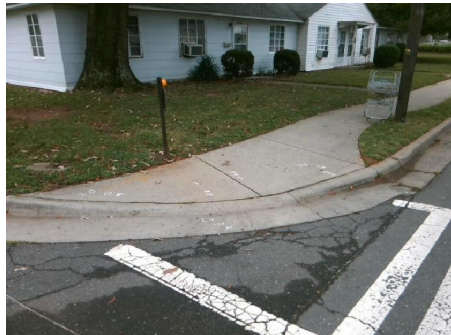
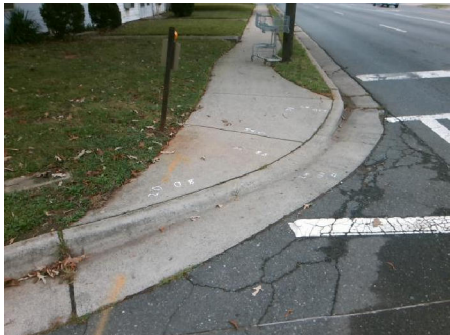
Not Found, R304.2.2, R304.5.3
