# Access Compliance Report

## Public Rights-of-Way

### (Curb Ramps)

| Intersection ID: 13708 | Main Street: WEST_BV | Cross Street: WICKFORD_PL | Location: SE |

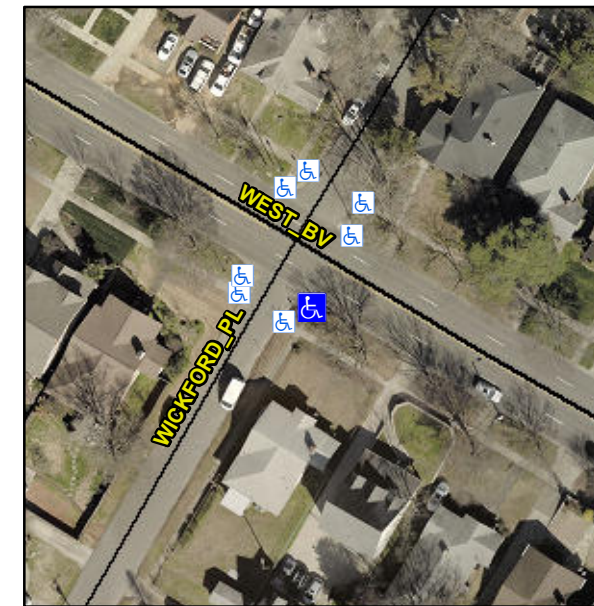
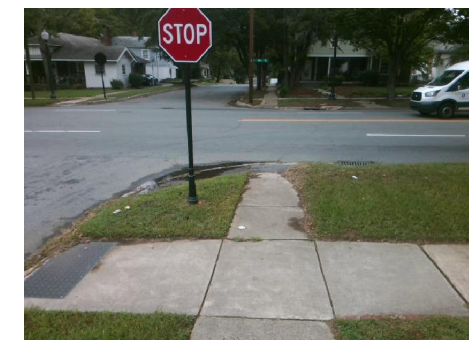
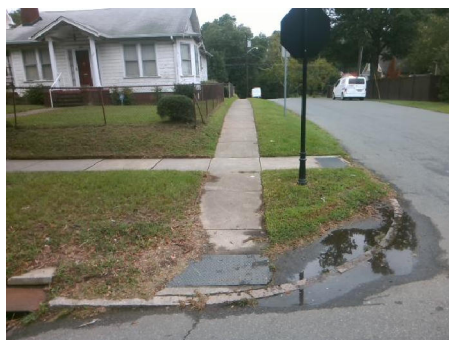
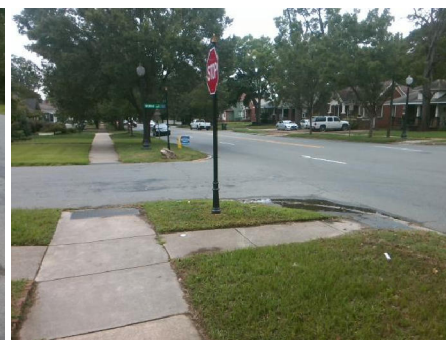
| ADA ID: 3F9CE5472DDE | Ramp Type: Directional1 | Initial Pass/Fail: Pass | Overall Compliance: No |
| Severity Score: 5.25 | | | |

**R304.5.3, R304.2.1, R304.5.4**

| Compliance | Description | Data | Compliance | Description | Data |
|---|---|---|---|---|---|
| Yes | Ramp Width (in) | 48.0 | No | Grade Break Slope (%) | 9.4 |
| No | Ramp XSlope (%) | 4.6 | | | |
| No | Landing Width (in) | 47.0 | Yes | DWS Contrast? | Yes |
| No | Landing X Slope (%) | 2.8 | Yes | DWS Full Width? | Yes |
| Yes | Gutter Ponding? | No | No | Gutter Slope (%) | 5.3 |

Possible Solutions:

**Remove & Replace Entire Ramp.  
Remove & Replace Gutter.**

Total Cost: \$ **2350.00**
