# Access Compliance Report

## Public Rights-of-Way

### (Curb Ramps)

Intersection ID: 12268	Main Street: BELLE_TERRE_AV	Cross Street: THE_PLAZA	Location: NW
ADA ID: 3FA44364849C	Ramp Type: Directional1	Initial Pass/Fail: Fail	Overall Compliance: No
Severity Score: 8.75			
Codes/Mitigation Info/Possible Solution		Field Measurements/Component Compliance

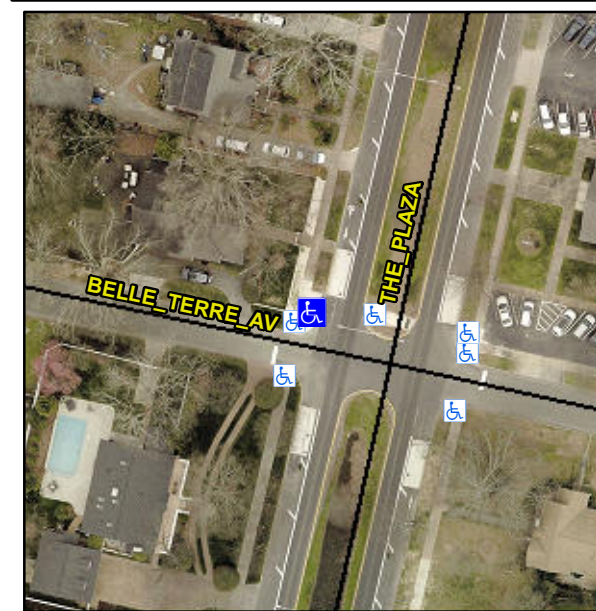
Compliance	Description	Data	Compliance	Description	Data
N/A	Ramp Length (in)	86.5	N/A	Grade Break?	N/A
No	Ramp Width (in)	47.5	N/A	Grade Break Slope (%)	0.0
Yes	Ramp Slope (%)	6.4	N/A	Grade Break XSlope (%)	0.0
Yes	Ramp XSlope (%)	0.9			
N/A	Flare Type LT	N/A	N/A	Flare Type RT	N/A
N/A	Flare Slope LT (%)	N/A	N/A	Flare Slope RT (%)	0.0
N/A	Flare Traversable LT?	N/A	N/A	Flare Traversable RT?	N/A
N/A	Landing Length (in)	0.0	N/A	DWS Provided?	N/A
N/A	Landing Width (in)	0.0	N/A	DWS Contrast?	N/A
N/A	Landing Slope (%)	0.0	N/A	DWS Length (in)	N/A
N/A	Landing X Slope (%)	0.0	N/A	DWS Full Width?	N/A
N/A	Landing Curb? (Y/N)	N/A	N/A	DWS Offset LT (in)	N/A
N/A	Shared Landing?	N/A	N/A	DWS Offset RT (in)	N/A
N/A	Gutter Ponding?	0.0	N/A	Gutter Slope (%)	N/A
N/A	Gutter Lip Ht (in)	0.0	N/A	Gutter X Slope (%)	N/A
N/A	Painted X Walk1?	No		Road Slope (%)	3.1
	X Walk 1 Direction	To E		Road X Slope (%)	0.3
	X Walk 1 Width (in)	N/A		Clear Space?	N/A

X Walk 1 Slope (%)	3.1	N/A	Clear Space to XWalk (in)	N/A
	X Walk 1 X Slope (%)	0.3	N/A	Storm Grate/Utility Hazard?	N/A
N/A	Ramp inside XWalk1?	N/A		Storm Grate/Utility Type	
N/A	Any Obstructions?	N/A			N/A
	Obstruction Type		Yes	Surface Condition? (G/P)	Good
			N/A	Curb Slope (%)	5.4

**Remove & Replace Entire Ramp.**
