# Access Compliance Report

## Public Rights-of-Way

### (Curb Ramps)

| Intersection ID: 54114 | Main Street: ENDAHVEN_VILLAGE_DR | Cross Street: ENDAHVEN_LN | Location: NE |

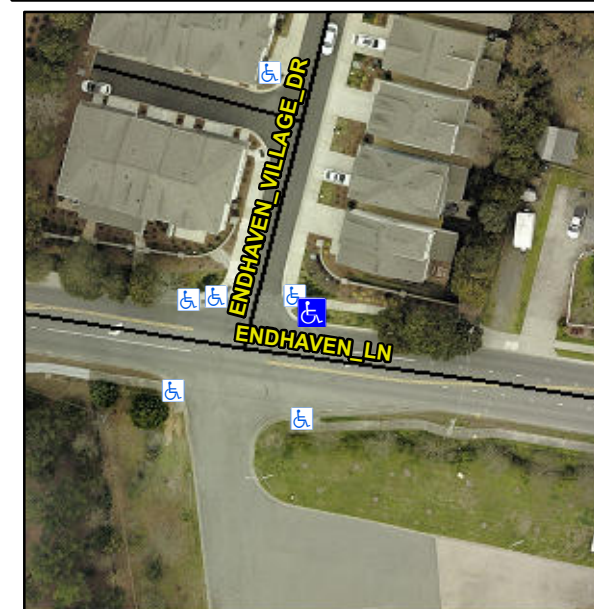
| ADA ID: 3FA5DD9A5D4E | Ramp Type: BlendTrans1 | Initial Pass/Fail: Fail | Overall Compliance: No |

**R304.5.1, R304.5.3**

| Compliance | Description | Data | Compliance | Description | Data |
|---|---|---|---|---|---|
| N/A | Ramp Length (in) | 83.0 | Yes | BlendTrans Slope (%) | 3.8 |
| No | Ramp Width (in) | 46.0 | No | BlendTrans XSlope (%) | 3.4 |

**Remove & Replace Curb Ramp With Two New Directional Ramps or Equivalent.**
