Access Compliance Report

Public Rights-of-Way

(Curb Ramps)

Intersection ID: 10038458	Main Street: SOUTHERN_PINE_BV	Cross Street: N/A	Location: NE
ADA ID: 3FC03D19ABF8	Ramp Type: PerpDiag	Initial Pass/Fail: Fail	Overall Compliance: No
Severity Score: 37.5			
Codes/Mitigation Info/Possible Solution		Field Measurements/Component Compliance

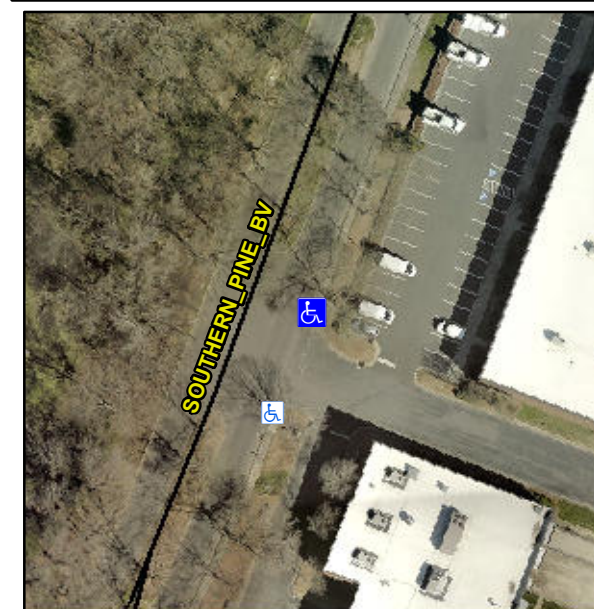
Not Found, R304.2.2, R304.5.3

Compliance	Description	Data	Compliance	Description	Data
N/A	Ramp Length (in)	44.0	No	Ramp Slope (%)	15.4
Yes	Ramp Width (in)	48.0	No	Ramp XSlope (%)	5.5
N/A	Flare Type LT	N/A	N/A	Flare Type RT	N/A
N/A	Flare Slope LT (%)	N/A	N/A	Flare Slope RT (%)	N/A
N/A	Flare Traversable LT?	N/A	N/A	Flare Traversable RT?	N/A
N/A	Landing Length (in)	N/A	N/A	DWS Provided?	N/A
N/A	Landing Width (in)	N/A	N/A	DWS Contrast?	N/A
N/A	Landing Slope (%)	N/A	N/A	DWS Length (in)	N/A
N/A	Landing X Slope (%)	N/A	N/A	DWS Full Width?	N/A
N/A	Landing Curb? (Y/N)	N/A	N/A	DWS Offset (in)	N/A
N/A	Shared Landing?	N/A			
N/A	Gutter Ponding?	N/A	N/A	Gutter Slope (%)	N/A
N/A	Gutter Lip Ht (in)	N/A	N/A	Gutter X Slope (%)	N/A
N/A	Painted X Walk1?	No	N/A	Painted X Walk2?	No
	X Walk 1 Direction	To W		X Walk 2 Direction	To S
N/A	X Walk 1 Width (in)	N/A	N/A	X Walk 2 Width (in)	N/A
	X Walk 1 Slope (%)	4.6		X Walk 2 Slope (%)	2.5
	X Walk 1 X Slope (%)	0.8		X Walk 2 X Slope (%)	8.3

N/A	Ramp inside XWalk1?	N/A	N/A	Ramp inside XWalk2?	N/A
	Road Slope (%)	1.4	N/A	Clear Space?	N/A
	Road X Slope (%)	2.5	N/A	Clear Space to XWalk (in)	N/A
N/A	Any Obstructions?	N/A	N/A	Storm Grate/Utility Hazard?	N/A
	Obstruction Type			Storm Grate/Utility Type	
		N/A			N/A
			Yes	Surface Condition? (G/P)	Good

Possible Solutions:

Remove & Replace Curb Ramp With Two New Directional Ramps or Equivalent.
