Access Compliance Report Public Rights-of-Way (Curb Ramps)

Intersection ID: 17958 Main Str	D: 17958 Main Street: HILLSDALE_AV		Cross Street: WALES_AV				SW
ADA ID: 3FC387DF0B2C Ramp Type: Perp		Initial Pass/Fail: Fail Overall Compliance: No			o Severity Score:	33.75	
Codes/Mitigation Info/Possible Solution		Field Measurements/Component Compliance					
Possible Solutions:						Compliance Description Data	
	Remove & Replace Entire Ramp.	N/A	Ramp Length (ir	n) 106.0	Yes	Ramp Slope (%)	7.3
	······································	No	Ramp Width (in)) 47.0	No	Ramp XSlope (%)	9.3
and the second s		N/A	Flare Type LT	N/A	N/A	Flare Type RT	N/A
A and A share the state of		N/A	Flare Slope LT ((%) N/A	N/A	Flare Slope RT (%)	N/A
WALES AV 6 5 6		N/A	Flare Traversab	ble LT? N/A	N/A	Flare Traversable RT?	N/A
	10 4	N/A	Landing Length	(in) N/A	N/A	DWS Provided?	N/A
	Surveyor Notes:	N/A	Landing Width ((in) N/A	N/A	DWS Contrast?	N/A
	N/A	N/A	Landing Slope ((%) N/A	N/A	DWS Length (in)	N/A

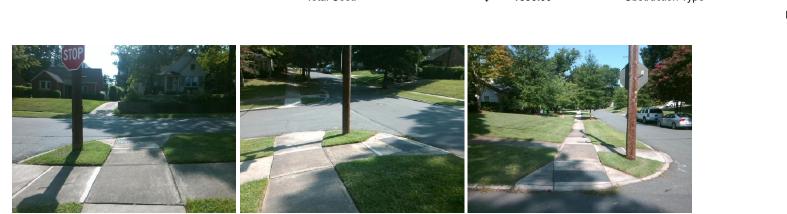
A CARLES AND A CAR		N/A	Landing X Slope	e (%) N/A	N/A	DWS Full Width?	N/A
		N/A	Landing Curb? (N/A	DWS Offset (in)	N/A
a start and a start and a start and a start a	2	N/A	Shared Landing	n? N/A			
	PROW/ADA:	N/A	Gutter Ponding	? N/A	N/A	Gutter Slope (%)	N/A
	R304.5.1, R304.5.3	N/A	Gutter Lip Ht (in		N/A	Gutter X Slope (%)	N/A
and the state of the state of the	1004.0.1, 1004.0.0	N/A	Painted X Walk	,	N/A	Painted X Walk2?	N/A
			X Walk 1 Directi	ion To SE		X Walk 2 Direction	N/A
A A A A A A A A A A A A A A A A A A A		N/A	X Walk 1 Width	(in) N/A	N/A	X Walk 2 Width (in)	N/A
Street 1 Name HILLSDALE AV	-		X Walk 1 Slope	()		X Walk 2 Slope (%)	N/A
Stop Condition-Street 2 None			X Walk 1 X Slop			X Walk 2 X Slope (%)	N/A
Street 2 Name N/A		N/A	Ramp inside XV		N/A	Ramp inside XWalk2?	N/A
Stop Condition-Street 1 N/A			' Road Slope (%)		N/A	Clear Space?	N/A
			Road X Slope (9	•	N/A	Clear Space to XWalk (in)	N/A
		N/A	Any Obstruction	,	N/A	Storm Grate/Utility Hazard?	N/A

Total Cost: \$ 1	850.00	Obstruction Typ			Storm Grate/Utility Type	
	+ -) -		1
