Access Compliance Report

Public Rights-of-Way

(Curb Ramps)

Intersection ID: 28056	Main Street: BLAKENEY_HEATH_RD	Cross Street: ELLINGTON_PARK_DR	Location: SE
ADA ID: 3FC58FF86F4C	Ramp Type: Directional1	Initial Pass/Fail: Fail	Overall Compliance: No
Severity Score: 1.25			
Codes/Mitigation Info/Possible Solution		Field Measurements/Component Compliance

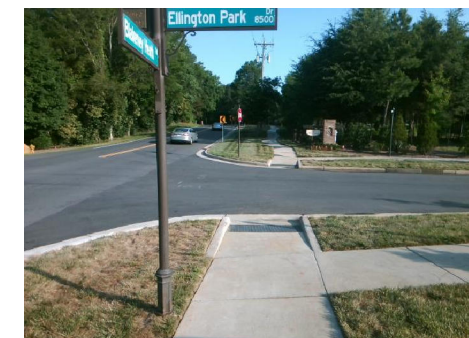
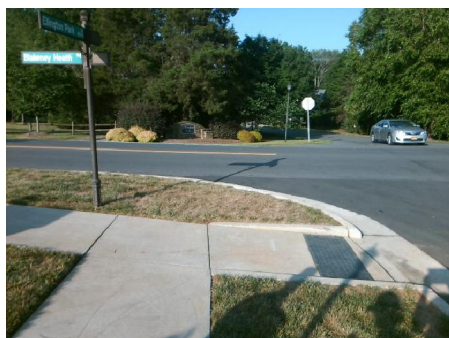
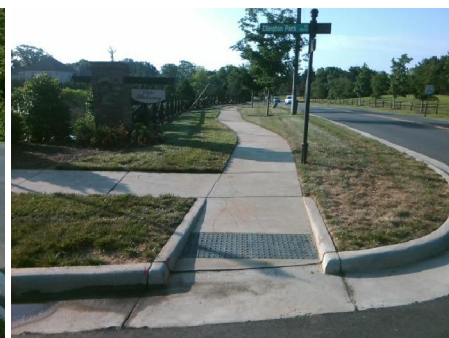
Compliance	Description	Data	Compliance	Description	Data
N/A	Ramp Length (in)	86.0	N/A	Grade Break?	N/A
Yes	Ramp Width (in)	60.0	N/A	Grade Break Slope (%)	0.0
Yes	Ramp Slope (%)	7.2	N/A	Grade Break XSlope (%)	0.0
No	Ramp XSlope (%)	2.3			
N/A	Flare Type LT	N/A	N/A	Flare Type RT	N/A
N/A	Flare Slope LT (%)	N/A	N/A	Flare Slope RT (%)	0.0
N/A	Flare Traversable LT?	N/A	N/A	Flare Traversable RT?	N/A
N/A	Landing Length (in)	0.0	N/A	DWS Provided?	N/A
N/A	Landing Width (in)	0.0	N/A	DWS Contrast?	N/A
N/A	Landing Slope (%)	0.0	N/A	DWS Length (in)	N/A
N/A	Landing X Slope (%)	0.0	N/A	DWS Full Width?	N/A
N/A	Landing Curb? (Y/N)	N/A	N/A	DWS Offset LT (in)	N/A
N/A	Shared Landing?	N/A	N/A	DWS Offset RT (in)	N/A
N/A	Gutter Ponding?	0.0	N/A	Gutter Slope (%)	N/A
N/A	Gutter Lip Ht (in)	0.0	N/A	Gutter X Slope (%)	N/A
N/A	Painted X Walk1?	No		Road Slope (%)	2.3
	X Walk 1 Direction	To NW		Road X Slope (%)	2.9
	X Walk 1 Width (in)	N/A		Clear Space?	N/A

X Walk 1 Slope (%)	2.3	N/A	Clear Space to XWalk (in)	N/A
	X Walk 1 X Slope (%)	2.9	N/A	Storm Grate/Utility Hazard?	N/A
N/A	Ramp inside XWalk1?	N/A		Storm Grate/Utility Type	
N/A	Any Obstructions?	N/A			N/A
	Obstruction Type		Yes	Surface Condition? (G/P)	Good
			N/A	Curb Slope (%)	7.2

Possible Solutions:

Remove & Replace Entire Ramp.

PROW/ADA:

R304.5.3
