# Access Compliance Report

## Public Rights-of-Way

### (Curb Ramps)

Intersection ID: 26392	Main Street: BEVINGTON_PL	Cross Street: BRECHIN_DR	Location: SW
ADA ID: 3FC729C0266B	Ramp Type: Perp	Initial Pass/Fail: Fail	Overall Compliance: No
		Severity Score: 37.5

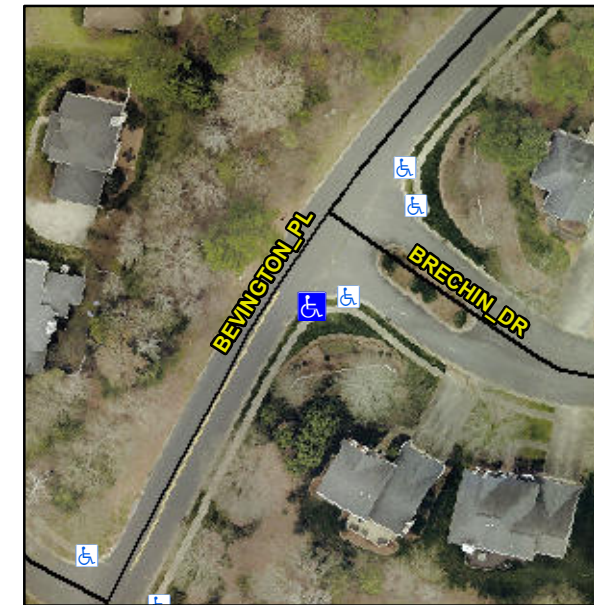
**R304.2.2, R304.5.3**

Compliance	Description	Data	Compliance	Description	Data
N/A	Ramp Length (in)	48.0	No	Ramp Slope (%)	10.0
Yes	Ramp Width (in)	48.0	No	Ramp XSlope (%)	7.6
N/A	Flare Type LT	N/A	N/A	Flare Type RT	N/A
N/A	Flare Slope LT (%)	N/A	N/A	Flare Slope RT (%)	N/A
N/A	Flare Traversable LT?	N/A	N/A	Flare Traversable RT?	N/A
N/A	Landing Length (in)	N/A	N/A	DWS Provided?	N/A
N/A	Landing Width (in)	N/A	N/A	DWS Contrast?	N/A
N/A	Landing Slope (%)	N/A	N/A	DWS Length (in)	N/A
N/A	Landing X Slope (%)	N/A	N/A	DWS Full Width?	N/A
N/A	Landing Curb? (Y/N)	N/A	N/A	DWS Offset (in)	N/A
N/A	Shared Landing?	N/A			
N/A	Gutter Ponding?	N/A	N/A	Gutter Slope (%)	N/A
N/A	Gutter Lip Ht (in)	N/A	N/A	Gutter X Slope (%)	N/A
N/A	Painted X Walk1?	No	N/A	Painted X Walk2?	N/A
	X Walk 1 Direction	To NW		X Walk 2 Direction	N/A
N/A	X Walk 1 Width (in)	N/A	N/A	X Walk 2 Width (in)	N/A
	X Walk 1 Slope (%)	0.3		X Walk 2 Slope (%)	N/A
	X Walk 1 X Slope (%)	2.1		X Walk 2 X Slope (%)	N/A

N/A	Ramp inside XWalk1?	N/A	N/A	Ramp inside XWalk2?	N/A
	Road Slope (%)	N/A	N/A	Clear Space?	N/A
	Road X Slope (%)	N/A	N/A	Clear Space to XWalk (in)	N/A
N/A	Any Obstructions?	N/A	N/A	Storm Grate/Utility Hazard?	N/A
	Obstruction Type			Storm Grate/Utility Type	
		N/A			N/A
			Yes	Surface Condition? (G/P)	Good

**Remove & Replace Entire Ramp.**

Total Cost: \$ 1850.00
