## Access Compliance Report Public Rights-of-Way (Curb Ramps)

Intersection ID: 27554 Main Street: BALLANTYNE\_MEADOWS\_DR Cross Street: DEER RIDGE\_LN Location: SW

ADA ID: 3FD527946053 Ramp Type: PerpDiag Initial Pass/Fail: Fail Overall Compliance: No Severity Score: 37.5

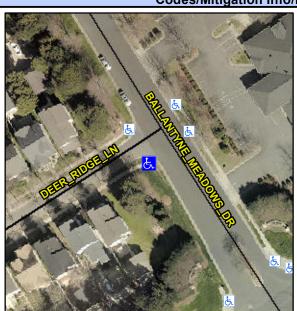
Comp	oliance Description	Data	Comp	oliance Description	Data
N/A	Ramp Length (in)	58.0	No	Ramp Slope (%)	8.8
Yes	Ramp Width (in)	48.0	No	Ramp XSlope (%)	9.4
N/A	Flare Type LT	N/A	N/A	Flare Type RT	N/A
N/A	Flare Slope LT (%)	N/A	N/A	Flare Slope RT (%)	N/A
N/A	Flare Traversable LT?	N/A	N/A	Flare Traversable RT?	N/A
N/A	Landing Length (in)	N/A	N/A	DWS Provided?	N/A
N/A	Landing Width (in)	N/A	N/A	DWS Contrast?	N/A
N/A	Landing Slope (%)	N/A	N/A	DWS Length (in)	N/A
N/A	Landing X Slope (%)	N/A	N/A	DWS Full Width?	N/A
N/A	Landing Curb? (Y/N)	N/A	N/A	DWS Offset (in)	N/A
N/A	Shared Landing?	N/A			
N/A	Gutter Ponding?	N/A	N/A	Gutter Slope (%)	N/A
N/A	Gutter Lip Ht (in)	N/A	N/A	Gutter X Slope (%)	N/A
N/A	Painted X Walk1?	No	N/A	Painted X Walk2?	No
	X Walk 1 Direction	To NE		X Walk 2 Direction	To N
N/A	X Walk 1 Width (in)	N/A	N/A	X Walk 2 Width (in)	N/A
	X Walk 1 Slope (%)	4.9		X Walk 2 Slope (%)	0.2
	X Walk 1 X Slope (%)	3.3		X Walk 2 X Slope (%)	4.9

N/A	Ramp inside XWalk1?	N/A	N/A	Ramp inside XWalk2?	N/A
	Road Slope (%)	7.8	N/A	Clear Space?	N/A
	Road X Slope (%)	0.5	N/A	Clear Space to XWalk (in)	N/A
N/A	Any Obstructions?	N/A	N/A	Storm Grate/Utility Hazard?	N/A
	Obstruction Type			Storm Grate/Utility Type	
		N/A			N/A

Remove & Replace Curb Ramp With Two New Directional Ramps or Equivalent.

R304.2.2, R304.5.3
