# Access Compliance Report

## Public Rights-of-Way

### (Curb Ramps)

Intersection ID: 10032174	Main Street: MORRIS_FIELD_DR	Cross Street: N/A	Location: S
ADA ID: 3FD7C662A543	Ramp Type: BlendTrans1	Initial Pass/Fail: Fail	Overall Compliance: No
		Severity Score: 10

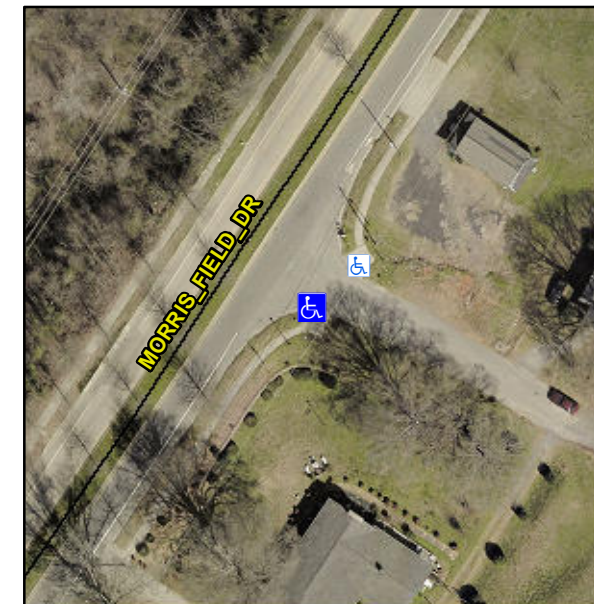
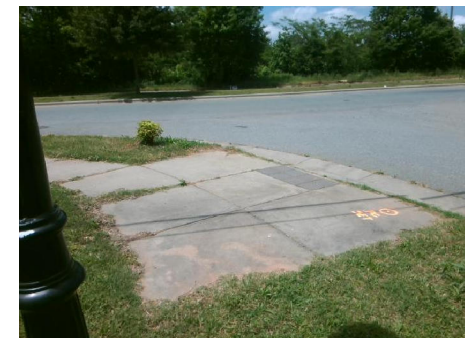
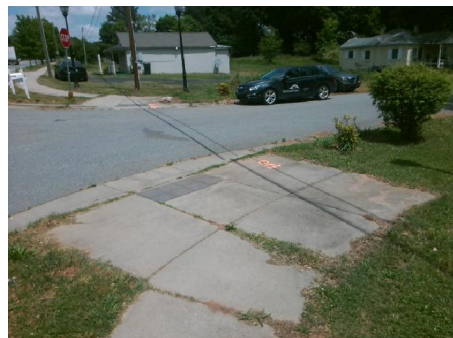
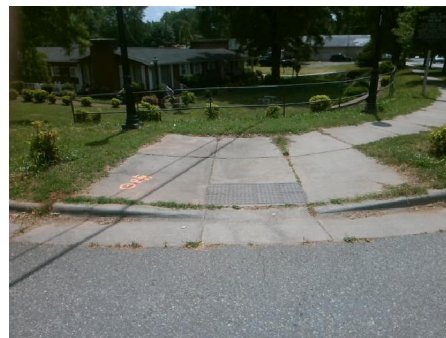
**MEDIAN ACROSS MORRIS FIELD DR**

**Not Found, R304.5.1, R304.5.3**

Compliance	Description	Data	Compliance	Description	Data
N/A	Ramp Length (in)	72.0	Yes	BlendTrans Slope (%)	1.1
No	Ramp Width (in)	46.0	No	BlendTrans XSlope (%)	2.6
N/A	Flare Type LT	N/A	N/A	Flare Type RT	N/A
N/A	Flare Slope LT (%)	N/A	N/A	Flare Slope RT (%)	N/A
N/A	Flare Traversable LT?	N/A	N/A	Flare Traversable RT?	N/A
N/A	Landing Length (in)	N/A	N/A	DWS Provided?	N/A
N/A	Landing Width (in)	N/A	N/A	DWS Contrast?	N/A
N/A	Landing Slope (%)	N/A	N/A	DWS Length (in)	N/A
N/A	Landing X Slope (%)	N/A	N/A	DWS Full Width?	N/A
N/A	Landing Curb? (Y/N)	N/A	N/A	DWS Offset (in)	N/A
N/A	Shared Landing?	N/A			
N/A	Gutter Ponding?	N/A	N/A	Gutter Slope (%)	N/A
N/A	Gutter Lip Ht (in)	N/A	N/A	Gutter X Slope (%)	N/A
N/A	Painted X Walk1?	No	N/A	Painted X Walk2?	N/A
	X Walk 1 Direction	To NE		X Walk 2 Direction	N/A
	X Walk 1 Width (in)	N/A		X Walk 2 Width (in)	N/A
	X Walk 1 Slope (%)	3.0		X Walk 2 Slope (%)	N/A
	X Walk 1 X Slope (%)	1.6		X Walk 2 X Slope (%)	N/A

N/A	Ramp inside XWalk1?	N/A	N/A	Ramp inside XWalk2?	N/A
	Road Slope (%)	1.6		Clear Space?	N/A
	Road X Slope (%)	3.0	N/A	Clear Space to XWalk (in)	N/A
N/A	Any Obstructions?	N/A	N/A	Storm Grate/Utility Hazard?	N/A
	Obstruction Type			Storm Grate/Utility Type	
		N/A			N/A
			Yes	Surface Condition? (G/P)	Good
			No	Curb Slope (%)	12.3

**Remove & Replace Curb Ramp With Two New Directional Ramps or Equivalent.**
