Access Compliance Report

Public Rights-of-Way

(Curb Ramps)

Intersection ID: 12508	Main Street: BELVEDERE_AV	Cross Street: CLUB_RD	Location: E
ADA ID: 3FD9344E2ED6	Ramp Type: Perp	Initial Pass/Fail: Fail	Overall Compliance: No
Codes/Mitigation Info/Possible Solution		Field Measurements/Component Compliance

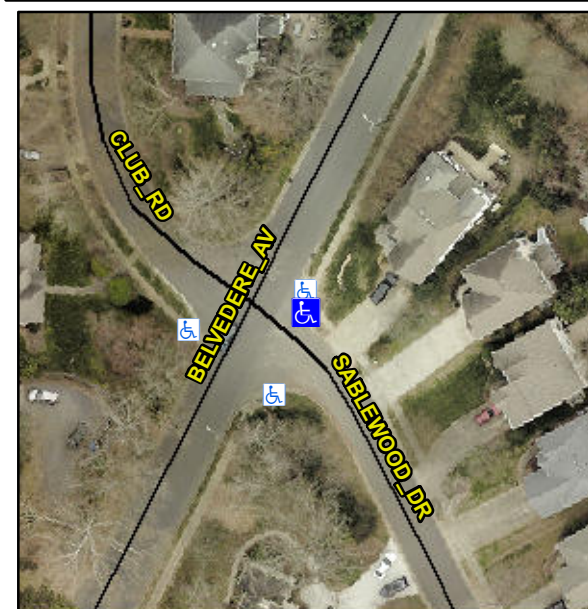
Not Found, R304.2.2, R304.5.3

Compliance	Description	Data	Compliance	Description	Data
N/A	Ramp Length (in)	49.0	No	Ramp Slope (%)	8.6
Yes	Ramp Width (in)	75.0	No	Ramp XSlope (%)	4.7
N/A	Flare Type LT	N/A	N/A	Flare Type RT	N/A
N/A	Flare Slope LT (%)	N/A	N/A	Flare Slope RT (%)	N/A
N/A	Flare Traversable LT?	N/A	N/A	Flare Traversable RT?	N/A
N/A	Landing Length (in)	N/A	N/A	DWS Provided?	N/A
N/A	Landing Width (in)	N/A	N/A	DWS Contrast?	N/A
N/A	Landing Slope (%)	N/A	N/A	DWS Length (in)	N/A
N/A	Landing X Slope (%)	N/A	N/A	DWS Full Width?	N/A
N/A	Landing Curb? (Y/N)	N/A	N/A	DWS Offset (in)	N/A
N/A	Shared Landing?	N/A			
N/A	Gutter Ponding?	N/A	N/A	Gutter Slope (%)	N/A
N/A	Gutter Lip Ht (in)	N/A	N/A	Gutter X Slope (%)	N/A
N/A	Painted X Walk1?	No	N/A	Painted X Walk2?	N/A
	X Walk 1 Direction	To SW		X Walk 2 Direction	N/A
N/A	X Walk 1 Width (in)	N/A	N/A	X Walk 2 Width (in)	N/A
	X Walk 1 Slope (%)	4.2		X Walk 2 Slope (%)	N/A
	X Walk 1 X Slope (%)	1.2		X Walk 2 X Slope (%)	N/A

N/A	Ramp inside XWalk1?	N/A	N/A	Ramp inside XWalk2?	N/A
	Road Slope (%)	N/A	N/A	Clear Space?	N/A
	Road X Slope (%)	N/A	N/A	Clear Space to XWalk (in)	N/A
N/A	Any Obstructions?	N/A	N/A	Storm Grate/Utility Hazard?	N/A
	Obstruction Type			Storm Grate/Utility Type	
		N/A			N/A
			Yes	Surface Condition? (G/P)	Good

Remove & Replace Entire Ramp.
