Access Compliance Report

Public Rights-of-Way

(Curb Ramps)

Intersection ID: N/A	Main Street: W_T_HARRIS_BV	Cross Street: N/A	Location: SW
ADA ID: 3FE754C92747	Ramp Type: PerpDiag	Initial Pass/Fail: Fail	Overall Compliance: No
			Severity Score: 21.25

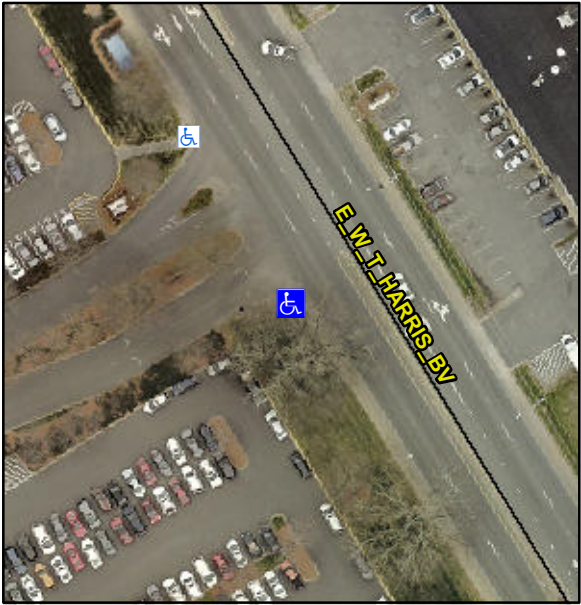
Possible Solutions:		Compliance	Description	Data
	Remove & Replace Curb Ramp With Two New Directional Ramps or Equivalent.		N/A	Ramp Length (in)	61.0
			No	Ramp Width (in)	45.0
			N/A	Flare Type LT	N/A
			N/A	Flare Slope LT (%)	N/A
			N/A	Flare Traversable LT?	N/A
			N/A	Landing Length (in)	N/A
			N/A	Landing Width (in)	N/A
			N/A	Landing Slope (%)	N/A
			N/A	Landing X Slope (%)	N/A
			N/A	Landing Curb? (Y/N)	N/A
			N/A	Shared Landing?	N/A
			N/A	Gutter Ponding?	N/A
			N/A	Gutter Lip Ht (in)	N/A
			N/A	Painted X Walk1?	No
				X Walk 1 Direction	To E
			N/A	X Walk 1 Width (in)	N/A
				X Walk 1 Slope (%)	0.3
				X Walk 1 X Slope (%)	0.2
			N/A	Ramp inside XWalk1?	N/A
<p>Surveyor Notes:</p> <p>N/A</p> <p>PROW/ADA:</p> <p>R304.5.1, R304.2.2</p>			N/A	Flare Type RT	N/A
			N/A	Flare Slope RT (%)	N/A
			N/A	Flare Traversable RT?	N/A

N/A	DWS Provided?	N/A
			N/A	DWS Contrast?	N/A
			N/A	DWS Length (in)	N/A
			N/A	DWS Full Width?	N/A
			N/A	DWS Offset (in)	N/A
			N/A	Gutter Slope (%)	N/A
			N/A	Gutter X Slope (%)	N/A
			N/A	Painted X Walk2?	No
				X Walk 2 Direction	To N
			N/A	X Walk 2 Width (in)	N/A
				X Walk 2 Slope (%)	1.1
				X Walk 2 X Slope (%)	1.2
			N/A	Ramp inside XWalk2?	N/A
			N/A	Clear Space?	N/A
			N/A	Clear Space to XWalk (in)	N/A
			N/A	Storm Grate/Utility Hazard?	N/A
				Storm Grate/Utility Type	
			N/A		N/A
			Yes	Surface Condition? (G/P)	Good
Street 1 Name	W T HARRIS BV				
Stop Condition-Street 2	None				
Street 2 Name	ENTRANCE				
Stop Condition-Street 1	StopSign				
Total Cost:	\$	3200.00
