# Access Compliance Report

## Public Rights-of-Way

Intersection ID: 13914	Main Street: CHESTERFIELD_AV	Cross Street: WESTOVER_ST	Location: E
ADA ID: 3FEF63EB2395	Ramp Type: PerpDiag	Initial Pass/Fail: Fail	Overall Compliance: No
		Severity Score: 22.5

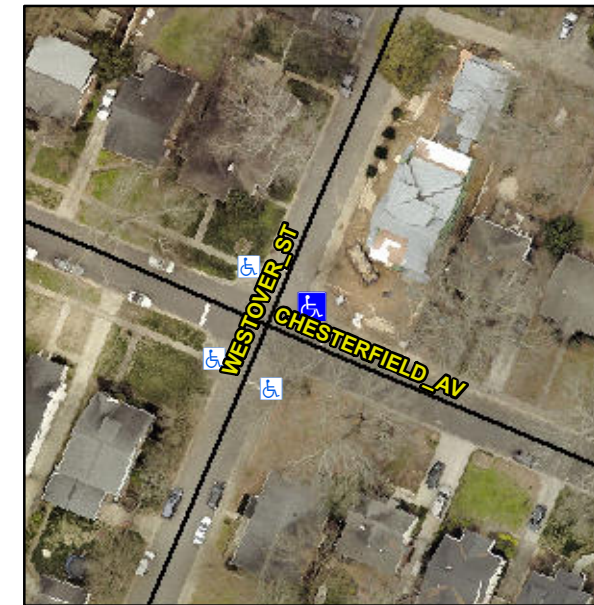
**Not Found, R304.5.1, R304.2.2, R304.5.3**

Compliance	Description	Data	Compliance	Description	Data
N/A	Ramp Length (in)	59.0	No	Ramp Slope (%)	9.2
No	Ramp Width (in)	41.0	No	Ramp XSlope (%)	5.0
N/A	Flare Type LT	N/A	N/A	Flare Type RT	N/A
N/A	Flare Slope LT (%)	N/A	N/A	Flare Slope RT (%)	N/A
N/A	Flare Traversable LT?	N/A	N/A	Flare Traversable RT?	N/A
N/A	Landing Length (in)	N/A	N/A	DWS Provided?	N/A
N/A	Landing Width (in)	N/A	N/A	DWS Contrast?	N/A
N/A	Landing Slope (%)	N/A	N/A	DWS Length (in)	N/A
N/A	Landing X Slope (%)	N/A	N/A	DWS Full Width?	N/A
N/A	Landing Curb? (Y/N)	N/A	N/A	DWS Offset (in)	N/A
N/A	Shared Landing?	N/A			
N/A	Gutter Ponding?	N/A	N/A	Gutter Slope (%)	N/A
N/A	Gutter Lip Ht (in)	N/A	N/A	Gutter X Slope (%)	N/A
N/A	Painted X Walk1?	No	N/A	Painted X Walk2?	No
	X Walk 1 Direction	To NW		X Walk 2 Direction	To SW
N/A	X Walk 1 Width (in)	N/A	N/A	X Walk 2 Width (in)	N/A
	X Walk 1 Slope (%)	4.5		X Walk 2 Slope (%)	3.3
	X Walk 1 X Slope (%)	3.2		X Walk 2 X Slope (%)	4.1

N/A	Ramp inside XWalk1?	N/A	N/A	Ramp inside XWalk2?	N/A
	Road Slope (%)	6.0	N/A	Clear Space?	N/A
	Road X Slope (%)	0.8	N/A	Clear Space to XWalk (in)	N/A
N/A	Any Obstructions?	N/A	N/A	Storm Grate/Utility Hazard?	N/A
	Obstruction Type			Storm Grate/Utility Type	
		N/A			N/A
			Yes	Surface Condition? (G/P)	Good

**Remove & Replace Curb Ramp With Two New Directional Ramps or Equivalent.**
