| Intersection ID: 10019201 | Main Street: WINTERFIELD_PL | Cross Street: N/A | Location: | E |
| ADA ID: 3FF3987DE7AB | Ramp Type: Perp | Initial Pass/Fail: Fail | Overall Compliance: No | Severity Score: 25 |

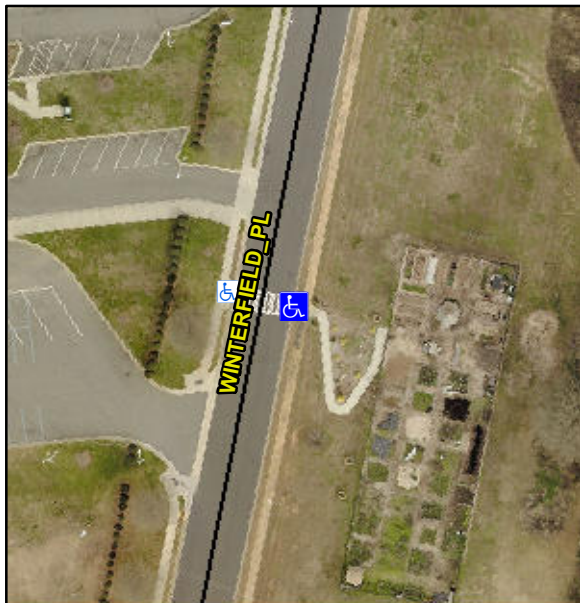
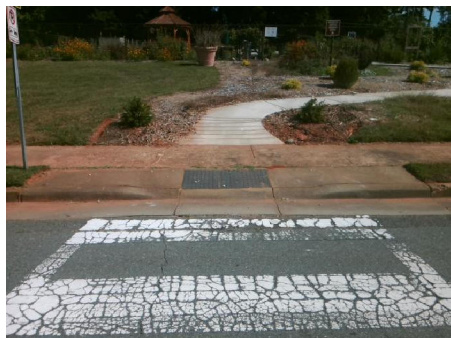
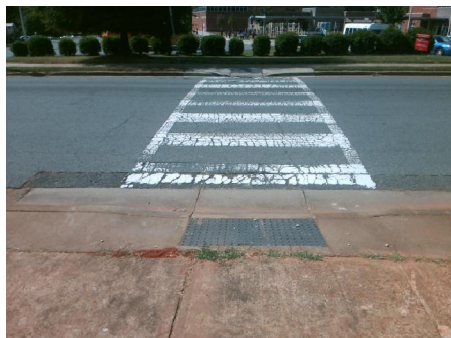
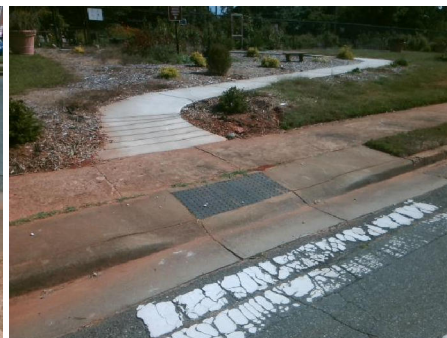
| Codes/Mitigation Info/Possible Solution | | | Field Measurements/Component Compliance | | | | | |
|---|---|---|---|---|---|---|---|---|
| | <b>Remove &amp; Replace Entire Ramp.</b> | | <b>N/A</b> | Ramp Length (in) | <b>28.0</b> | <b>No</b> | Ramp Slope (%) | <b>14.5</b> |
| <b>Not Found, R304.2.2</b> | | | <b>N/A</b> | Gutter Lip Ht (in) | <b>0.5</b> | <b>N/A</b> | Gutter X Slope (%) | <b>N/A</b> |

| Codes/Mitigation Info/Possible Solution | | | Field Measurements/Component Compliance | | | | | |
|---|---|---|---|---|---|---|---|---|
| | Possible Solutions: | | <b>Compliance</b> | <b>Description</b> | <b>Data</b> | <b>Compliance</b> | <b>Description</b> | <b>Data</b> |
| Total Cost: | | <b>\$ 1850.00</b> | | | | | | |
