# Access Compliance Report

## Public Rights-of-Way

### (Curb Ramps)

Intersection ID: 18189	Main Street: S_WENDOVER_RD	Cross Street: FOREST_DR	Location: S
ADA ID: 3FF65E1C5D22	Ramp Type: PerpDiag	Initial Pass/Fail: Fail	Overall Compliance: No
Severity Score: 12.5			
Codes/Mitigation Info/Possible Solution		Field Measurements/Component Compliance

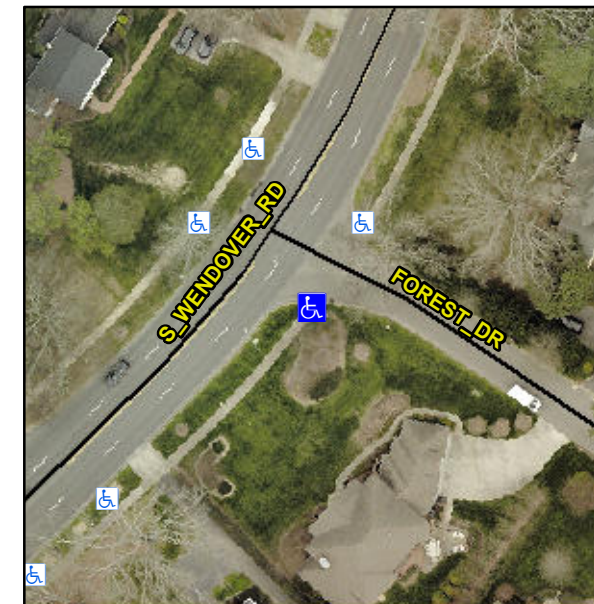
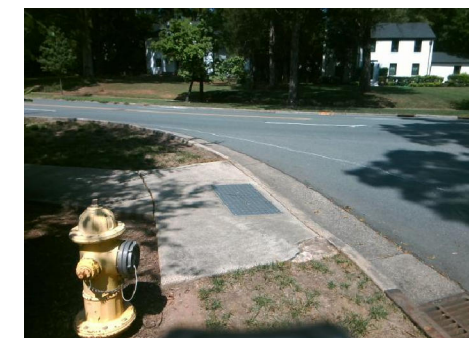
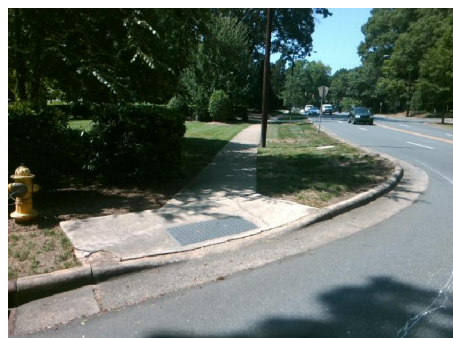
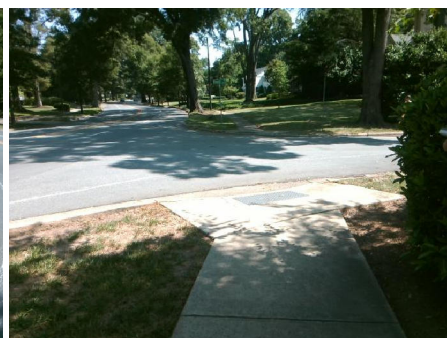
**Not Found, R304.5.3**

Compliance	Description	Data	Compliance	Description	Data
N/A	Ramp Length (in)	62.0	Yes	Ramp Slope (%)	5.1
Yes	Ramp Width (in)	48.0	No	Ramp XSlope (%)	5.4
N/A	Flare Type LT	N/A	N/A	Flare Type RT	N/A
N/A	Flare Slope LT (%)	N/A	N/A	Flare Slope RT (%)	N/A
N/A	Flare Traversable LT?	N/A	N/A	Flare Traversable RT?	N/A
N/A	Landing Length (in)	N/A	N/A	DWS Provided?	N/A
N/A	Landing Width (in)	N/A	N/A	DWS Contrast?	N/A
N/A	Landing Slope (%)	N/A	N/A	DWS Length (in)	N/A
N/A	Landing X Slope (%)	N/A	N/A	DWS Full Width?	N/A
N/A	Landing Curb? (Y/N)	N/A	N/A	DWS Offset (in)	N/A
N/A	Shared Landing?	N/A			
N/A	Gutter Ponding?	N/A	N/A	Gutter Slope (%)	N/A
N/A	Gutter Lip Ht (in)	N/A	N/A	Gutter X Slope (%)	N/A
N/A	Painted X Walk1?	No	N/A	Painted X Walk2?	No
	X Walk 1 Direction	To NE		X Walk 2 Direction	To NW
N/A	X Walk 1 Width (in)	N/A	N/A	X Walk 2 Width (in)	N/A
	X Walk 1 Slope (%)	2.2		X Walk 2 Slope (%)	5.6
	X Walk 1 X Slope (%)	3.8		X Walk 2 X Slope (%)	0.5

N/A	Ramp inside XWalk1?	N/A	N/A	Ramp inside XWalk2?	N/A
	Road Slope (%)	3.8	N/A	Clear Space?	N/A
	Road X Slope (%)	5.1	N/A	Clear Space to XWalk (in)	N/A
N/A	Any Obstructions?	N/A	N/A	Storm Grate/Utility Hazard?	N/A
	Obstruction Type			Storm Grate/Utility Type	
		N/A			N/A
		Yes		Surface Condition? (G/P)	Good

**Remove & Replace Curb Ramp With Two New Directional Ramps or Equivalent.**

Total Cost: \$ 3200.00
