# Access Compliance Report

## Public Rights-of-Way

### (Curb Ramps)

| Intersection ID: 52432 | Main Street: ALEXA REED RD | Cross Street: CRAVEN THOMAS RD | Location: NW |

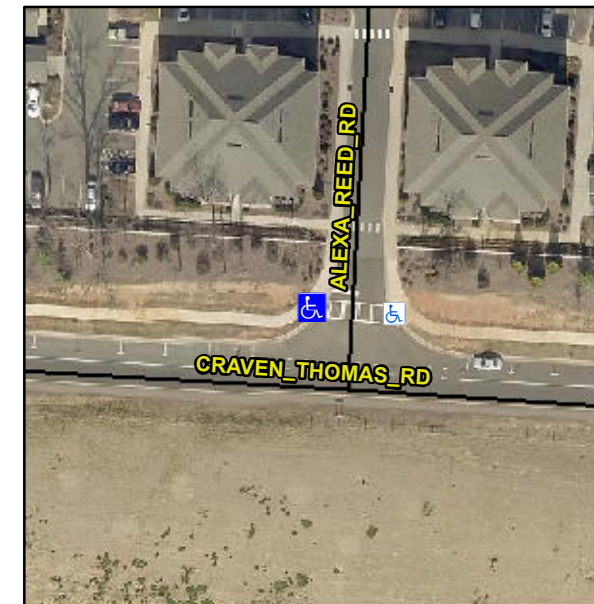
| ADA ID: 3FFE53FBD008 | Ramp Type: Para | Initial Pass/Fail: Fail | Overall Compliance: No |
| | | Severity Score: 1.25 | |

**R304.5.3**

| Compliance | Description | Data | Compliance | Description | Data |
|---|---|---|---|---|---|
| Yes | Ramp XSlope LT (%) | 0.8 | No | Ramp XSlope RT (%) | 3.0 |

**Remove & Replace Entire Ramp.**

**\$ 1600.00**
