# Access Compliance Report

## Public Rights-of-Way

### (Curb Ramps)

Intersection ID: 12370	Main Street: S_CLARKSON_ST	Cross Street: POST_ST	Location:	N
ADA ID: 4002D3C15E88	Ramp Type: BlendTrans1	Initial Pass/Fail: Fail	Overall Compliance: No	Severity Score: 10

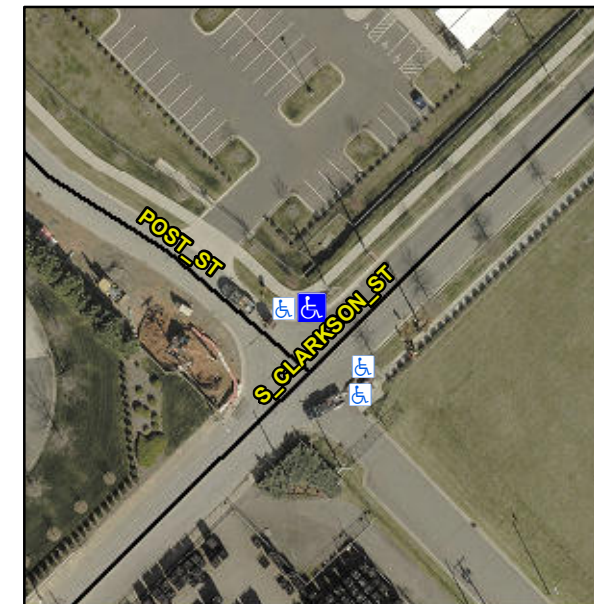
**Not Found, R304.5.1, R304.5.3**

Compliance	Description	Data	Compliance	Description	Data
N/A	Ramp Length (in)	96.0	Yes	BlendTrans Slope (%)	4.5
No	Ramp Width (in)	47.0	No	BlendTrans XSlope (%)	2.7
N/A	Flare Type LT	N/A	N/A	Flare Type RT	N/A
N/A	Flare Slope LT (%)	N/A	N/A	Flare Slope RT (%)	N/A
N/A	Flare Traversable LT?	N/A	N/A	Flare Traversable RT?	N/A
N/A	Landing Length (in)	N/A	N/A	DWS Provided?	N/A
N/A	Landing Width (in)	N/A	N/A	DWS Contrast?	N/A
N/A	Landing Slope (%)	N/A	N/A	DWS Length (in)	N/A
N/A	Landing X Slope (%)	N/A	N/A	DWS Full Width?	N/A
N/A	Landing Curb? (Y/N)	N/A	N/A	DWS Offset (in)	N/A
N/A	Shared Landing?	N/A			
N/A	Gutter Ponding?	N/A	N/A	Gutter Slope (%)	N/A
N/A	Gutter Lip Ht (in)	N/A	N/A	Gutter X Slope (%)	N/A
N/A	Painted X Walk1?	No	N/A	Painted X Walk2?	N/A
	X Walk 1 Direction	To SE		X Walk 2 Direction	N/A
	X Walk 1 Width (in)	N/A		X Walk 2 Width (in)	N/A
	X Walk 1 Slope (%)	3.4		X Walk 2 Slope (%)	N/A
	X Walk 1 X Slope (%)	1.6		X Walk 2 X Slope (%)	N/A

N/A	Ramp inside XWalk1?	N/A	N/A	Ramp inside XWalk2?	N/A
	Road Slope (%)	1.6		Clear Space?	N/A
	Road X Slope (%)	3.4	N/A	Clear Space to XWalk (in)	N/A
N/A	Any Obstructions?	N/A	N/A	Storm Grate/Utility Hazard?	N/A
	Obstruction Type			Storm Grate/Utility Type	
		N/A			N/A
			Yes	Surface Condition? (G/P)	Good
			No	Curb Slope (%)	10.5

**Remove & Replace Curb Ramp With Two New Directional Ramps or Equivalent.**
