Access Compliance Report

Public Rights-of-Way

(Curb Ramps)

| Intersection ID: 48147 | Main Street: MCCAMEY_DR | Cross Street: FRANKLIN_MEADOWS_DR | Location: SE |

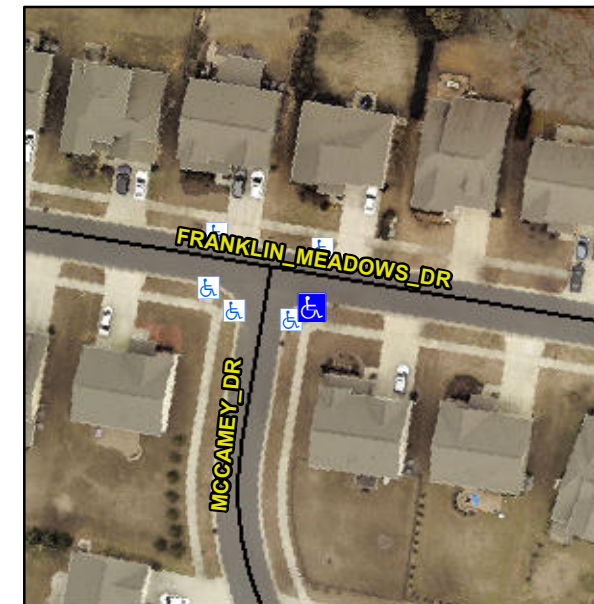
| ADA ID: 4007673E0F74 | Ramp Type: Perp | Initial Pass/Fail: Fail | Overall Compliance: No |
| Severity Score: 8.75 | | | |

R304.5.1

| Compliance | Description | Data | Compliance | Description | Data |
|---|---|---|---|---|---|
| No | Ramp Width (in) | 47.0 | Yes | Ramp XSlope (%) | 0.5 |

Remove & Replace Entire Ramp.

\$ 1850.00
