Access Compliance Report Public Rights-of-Way (Curb Ramps)

Intersection ID: 50102	ersection ID: 50102 Main Street: DOVE_MEADOW_DR			Cross Street: PECAN_FLATS_DR				Location:	NW	
ADA ID: 4010B3C6F2B8	DA ID: 4010B3C6F2B8 Ramp Type: Perp			Initial Pass/Fail: Fail Overall Compliance: No				o Severity Score:	8.75	
Codes/Mitigation Info/Possible Solution				Field Measurements/Component Compliance						
	1 1	Possible Solutions:	Compliance Description D			Data	ata Compliance Description		Data

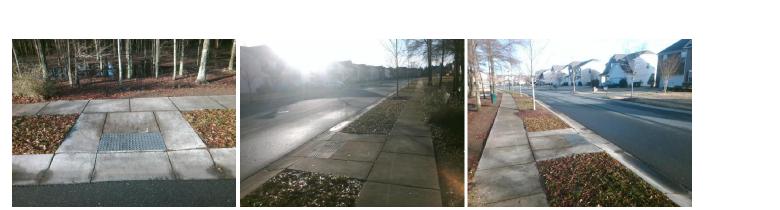
* \ /	Remove & Replace Entire Ramp		N/A	Ramp Length (in)	72.0	Yes	Ramp Slope (%)	5.0	
				No	Ramp Width (in)	47.0	Yes	Ramp XSlope (%)	1.3	
Contraction of the second	> Jal	1		N/A	Flare Type LT	N/A	N/A	Flare Type RT	N/A	
A MARINE IN THE	E CONTRACTOR			N/A	Flare Slope LT (%)	N/A	N/A	Flare Slope RT (%)	N/A	
a state of the sta	ALCON .			N/A	Flare Traversable LT?	N/A	N/A	Flare Traversable RT?	N/A	
A A A A A A A A A A A A A A A A A A A	S.			N/A	Landing Length (in)	N/A	N/A	DWS Provided?	N/A	
		Surveyor Notes:		N/A	Landing Width (in)	N/A	N/A	DWS Contrast?	N/A	
ta 🖌 🕹 🕹	1.16	N/A		N/A	Landing Slope (%)	N/A	N/A	DWS Length (in)	N/A	
	and a			N/A	Landing X Slope (%)	N/A	N/A	DWS Full Width?	N/A	
the second se	1 mar			N/A	Landing Curb? (Y/N)	N/A	N/A	DWS Offset (in)	N/A	
a set a set of a	18.4 2			N/A	Shared Landing?	N/A				
	PROW/ADA:		N/A	Gutter Ponding?	N/A	N/A	Gutter Slope (%)	N/A		
		Not Found, R304.5.1		N/A	Gutter Lip Ht (in)	N/A	N/A	Gutter X Slope (%)	N/A
