# Access Compliance Report

## Public Rights-of-Way

### (Curb Ramps)

Intersection ID: 12618	Main Street: E_5TH_ST	Cross Street: N_CALDWELL_ST	Location: E
ADA ID: 4012CB94A1A1	Ramp Type: Perp	Initial Pass/Fail: Fail	Overall Compliance: No
Severity Score: 21.25			
Codes/Mitigation Info/Possible Solution		Field Measurements/Component Compliance

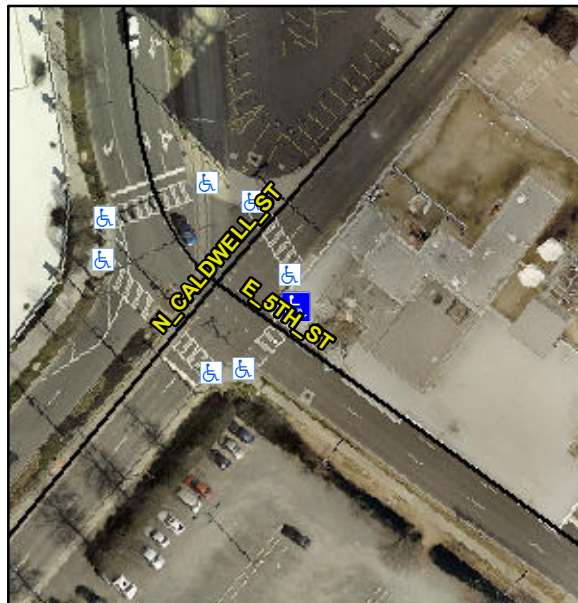
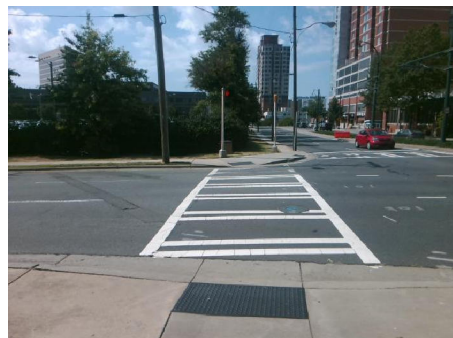
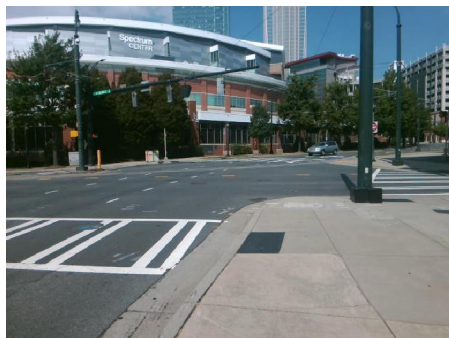
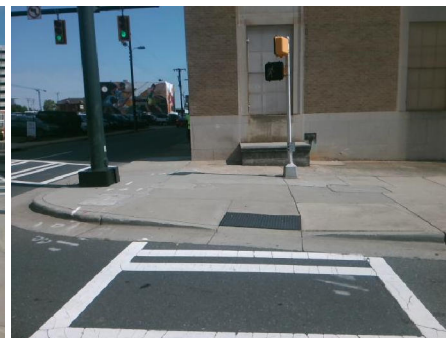
**Not Found, R304.5.1, R304.5.3**

Compliance	Description	Data	Compliance	Description	Data
N/A	Ramp Length (in)	53.0	Yes	Ramp Slope (%)	5.4
No	Ramp Width (in)	47.0	No	Ramp XSlope (%)	5.2
N/A	Flare Type LT	N/A	N/A	Flare Type RT	N/A
N/A	Flare Slope LT (%)	N/A	N/A	Flare Slope RT (%)	N/A
N/A	Flare Traversable LT?	N/A	N/A	Flare Traversable RT?	N/A
N/A	Landing Length (in)	N/A	N/A	DWS Provided?	N/A
N/A	Landing Width (in)	N/A	N/A	DWS Contrast?	N/A
N/A	Landing Slope (%)	N/A	N/A	DWS Length (in)	N/A
N/A	Landing X Slope (%)	N/A	N/A	DWS Full Width?	N/A
N/A	Landing Curb? (Y/N)	N/A	N/A	DWS Offset (in)	N/A
N/A	Shared Landing?	N/A			
N/A	Gutter Ponding?	N/A	N/A	Gutter Slope (%)	N/A
N/A	Gutter Lip Ht (in)	N/A	N/A	Gutter X Slope (%)	N/A
N/A	Painted X Walk1?	Yes	N/A	Painted X Walk2?	N/A
	X Walk 1 Direction	To SW		X Walk 2 Direction	N/A
N/A	X Walk 1 Width (in)	105.0	N/A	X Walk 2 Width (in)	N/A
	X Walk 1 Slope (%)	1.8		X Walk 2 Slope (%)	N/A
	X Walk 1 X Slope (%)	3.5		X Walk 2 X Slope (%)	N/A

N/A	Ramp inside XWalk1?	Yes	N/A	Ramp inside XWalk2?	N/A
	Road Slope (%)	N/A	N/A	Clear Space?	N/A
	Road X Slope (%)	N/A	N/A	Clear Space to XWalk (in)	N/A
N/A	Any Obstructions?	N/A	N/A	Storm Grate/Utility Hazard?	N/A
	Obstruction Type			Storm Grate/Utility Type	
		N/A			N/A
		Yes		Surface Condition? (G/P)	Good

**Remove & Replace Entire Ramp.**
