## **Access Compliance Report Public Rights-of-Way** (Curb Ramps)

Intersection ID: 24124 Main Street: DEHAVILLAND DR **Cross Street: PILCHER DR** Location: NW ADA ID: 40146B4007ED Ramp Type: PerpDiag Initial Pass/Fail: Pass **Overall Compliance: No** Severity Score: 20.25

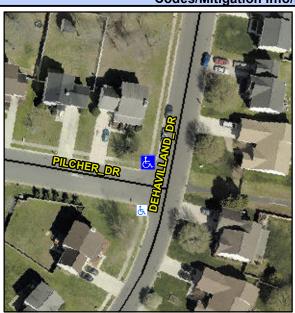
Field Measurements/Component Compliance					
Compliance Description Data		Compliance Description		Data	
N/A	Ramp Length (in)	95.0	Yes	Ramp Slope (%)	6.1
Yes	Ramp Width (in)	68.0	No	Ramp XSlope (%)	2.7
N/A	Flare Type LT	Sloped	N/A	Flare Type RT	N/A
N/A	Flare Slope LT (%)	6.8	N/A	Flare Slope RT (%)	8.6
N/A	Flare Traversable LT?	No	N/A	Flare Traversable RT?	No
No	Landing Length (in)	N/A	No	DWS Provided?	No
No	Landing Width (in)	N/A	N/A	DWS Contrast?	No
No	Landing Slope (%)	N/A	N/A	DWS Length (in)	N/A
No	Landing X Slope (%)	N/A	N/A	DWS Full Width?	No
N/A	Landing Curb? (Y/N)	No	N/A	DWS Offset (in)	N/A
N/A	Shared Landing?	No			
Yes	Gutter Ponding?	No	Yes	Gutter Slope (%)	2.5
Yes	Gutter Lip Ht (in)	0.0	Yes	Gutter X Slope (%)	0.6
N/A	Painted X Walk1?	No	N/A	Painted X Walk2?	No
	X Walk 1 Direction	To SW		X Walk 2 Direction	To SE
N/A	X Walk 1 Width (in)	N/A	N/A	X Walk 2 Width (in)	N/A
	X Walk 1 Slope (%)	1.3		X Walk 2 Slope (%)	5.5

X Walk 1 X Slope (%)	1.7		X Walk 2 X Slope (%)	0.3
N/A	Ramp inside XWalk1?	N/A	N/A	Ramp inside XWalk2?	N/A
	Road Slope (%)	0.8	N/A	Clear Space?	Yes
	Road X Slope (%)	4.9	N/A	Clear Space to XWalk (in)	N/A
Yes	Any Obstructions?	No	Yes	Storm Grate/Utility Hazard?	No
	Obstruction Type			Storm Grate/Utility Type	
		N/A			N/A
			Yes	Surface Condition? (G/P)	Good

Possible Solutions: Remove & Replace Curb Ramp With Two New Directional Ramps or Equivalent. Surveyor Notes: N/A PROW/ADA: R304.5.3, R304.2.1, R304.2.2-Perp, R304.3.2-Para, R305
