Access Compliance Report Public Rights-of-Way (Curb Ramps)

Intersection ID: 27715 Main Street: HAMPSHIRE_HILL_RD Cross					OLD_ACRES_CT	Location:	NE			
ADA ID: 401B3BBF8DF0 Ramp Type: PerpDiag Initia					ail: Pass Overall	o Severity Score:	0.25			
Codes/Mitigation Info/Possible Solution					Field Measurements/Component Compliance					
		Possible Solutions:		Compliance Description		Data Compliance Description		liance Description	Data	
		Remove & Replace Curb Ramp Wit Two New Directional Ramps or Equivalent. Remove & Replace Gutter.	np With	N/A	Ramp Length (in)	48.0	Yes	Ramp Slope (%)	7.5

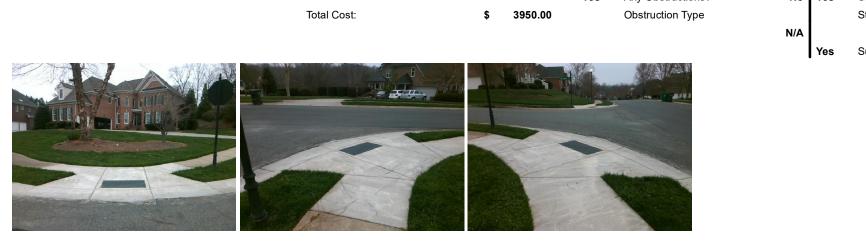
•	Yes	Ramp Width (in)	56.0	No	Ramp XSlope (%)	3.5	
			се	N/A	Flare Type LT	Sloped	N/A	Flare Type RT	N/A	
				N/A	Flare Slope LT (%)	2.5	N/A	Flare Slope RT (%)	7.2	
				N/A	Flare Traversable LT?	No	N/A	Flare Traversable RT?	No	
	1888 4			Yes	Landing Length (in)	52.0	Yes	DWS Provided?	Yes	
	TABLE STREET	Surveyor Notes:		Yes	Landing Width (in)	56.0	Yes	DWS Contrast?	Yes

6.	N/A		No	Landing Slope (%)	3.2	No	DWS Length (in)	23.5	
	OLD AGRES OT			No	Landing X Slope (%)	4.1	Yes	DWS Full Width?	Yes	
A COL				N/A	Landing Curb? (Y/N)	No	No	DWS Offset (in)	6.0	
				N/A	Shared Landing?	No				
	July Press	PROW/ADA: Not Found, R304.5.3, R304.2.2-F R304.3.2-Para, R305.1.4, R305.2		Yes	Gutter Ponding?	No	Yes	Gutter Slope (%)	1.8	
	17/2 18 M		2-Perp.	Yes	Gutter Lip Ht (in)	0.0	No	Gutter X Slope (%)	4.4

• •	N/A	Painted X Walk1?	No	N/A	Painted X Walk2?	No	
	AT-1-17223				X Walk 1 Direction	To W		X Walk 2 Direction	To S	
	The Caller			N/A	X Walk 1 Width (in)	N/A	N/A	X Walk 2 Width (in)	N/A	
Street 1 Name	HAMPHIRE HILL RD	_			X Walk 1 Slope (%)	2.5		X Walk 2 Slope (%)	2.2	
Stop Condition-Street 2	None				X Walk 1 X Slope (%)	1.5		X Walk 2 X Slope (%)	5.7	
Street 2 Name	OLD ACRES CT			N/A	Ramp inside XWalk1?	N/A	N/A	Ramp inside XWalk2?	N/A	
Stop Condition-Street 1	StopSign				Road Slope (%)	4.7	N/A	Clear Space?	Yes	
					Road X Slope (%)	1.9	N/A	Clear Space to XWalk (in)	N/A	
				Yes	Any Obstructions?	No	Yes	Storm Grate/Utility Hazard?	No	
		Total Cost: \$	3950.00		Obstruction Type			Storm Grate/Utility Type		
						N/A			N/A
