Access Compliance Report Public Rights-of-Way (Curb Ramps)

Intersection ID: 21548 Main Street: OLD_PROVIDENCE_RD Cross Street: PROVIDENCE_RD Location: SE **Overall Compliance: No ADA ID: 401CF0CF9F60** Ramp Type: Perp Initial Pass/Fail: Fail Severity Score: 21.25

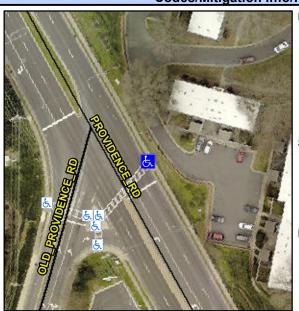
Field Measurements/Component Compliance								
Comp	liance Description	Data	Comp	liance Description	Data			
N/A	Ramp Length (in)	71.0	No	Ramp Slope (%)	9.0			
No	Ramp Width (in)	47.0	Yes	Ramp XSlope (%)	0.8			
N/A	Flare Type LT	N/A	N/A	Flare Type RT	N/A			
N/A	Flare Slope LT (%)	N/A	N/A	Flare Slope RT (%)	N/A			
N/A	Flare Traversable LT?	N/A	N/A	Flare Traversable RT?	N/A			
N/A	Landing Length (in)	N/A	N/A	DWS Provided?	N/A			
N/A	Landing Width (in)	N/A	N/A	DWS Contrast?	N/A			
N/A	Landing Slope (%)	N/A	N/A	DWS Length (in)	N/A			
N/A	Landing X Slope (%)	N/A	N/A	DWS Full Width?	N/A			
N/A	Landing Curb? (Y/N)	N/A	N/A	DWS Offset (in)	N/A			
N/A	Shared Landing?	N/A						
N/A	Gutter Ponding?	N/A	N/A	Gutter Slope (%)	N/A			
N/A	Gutter Lip Ht (in)	N/A	N/A	Gutter X Slope (%)	N/A			
N/A	Painted X Walk1?	Yes	N/A	Painted X Walk2?	N/A			
	X Walk 1 Direction	To SW		X Walk 2 Direction	N/A			
N/A	X Walk 1 Width (in)	70.0	N/A	X Walk 2 Width (in)	N/A

X Walk 1 Slope (%)	0.6		X Walk 2 Slope (%)	N/A			
	X Walk 1 X Slope (%)	2.3		X Walk 2 X Slope (%)	N/A			
N/A	Ramp inside XWalk1?	Yes	N/A	Ramp inside XWalk2?	N/A			
	Road Slope (%)	N/A	N/A	Clear Space?	N/A			
	Road X Slope (%)	N/A	N/A	Clear Space to XWalk (in)	N/A			
N/A	Any Obstructions?	N/A	N/A	Storm Grate/Utility Hazard?	N/A			
	Obstruction Type			Storm Grate/Utility Type				
		N/A			N/A			
			Yes	Surface Condition? (G/P)	Good

Possible Solutions:						
Remove & Replace Entire Ramp.						
Surveyor Notes:						
N/A						
NA						
PROW/ADA:						
Not Found, R304.5.1, R304.2.2
