Access Compliance Report Public Rights-of-Way (Curb Ramps)

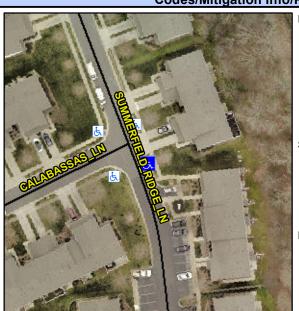
Intersection ID: N/A Main Street: SUMMERFIELD RIDGE LN **Cross Street: CALABASSAS LN** Location: SE **Overall Compliance: No** ADA ID: 40246593C147 Ramp Type: Perp Initial Pass/Fail: Fail Severity Score: 33.75

Field Measurements/Component Compliance								
Comp	liance Description	Data	Comp	liance	Description	Data		
N/A	Ramp Length (in)	49.0	No	Ram	o Slope (%)	9.0		
No	Ramp Width (in)	47.0	No	Ram	xSlope (%)	5.3		
N/A	Flare Type LT	N/A	N/A Flare Type RT		N/A			
N/A	Flare Slope LT (%)	N/A	N/A	N/A Flare Slope RT (%)				
N/A	Flare Traversable LT?	No	N/A	/A Flare Traversable RT?		No		
N/A	Landing Length (in)	N/A	N/A	DWS Provided?		N/A		
N/A	Landing Width (in)	N/A	N/A	DWS Contrast?		N/A		
N/A	Landing Slope (%)	N/A	N/A	DWS	Length (in)	N/A		
N/A	Landing X Slope (%)	N/A	N/A	DWS	Full Width?	N/A		
N/A	Landing Curb? (Y/N)	N/A	N/A	DWS	Offset (in)	N/A		
N/A	Shared Landing?	N/A						
N/A	Gutter Ponding?	N/A	N/A	Gutte	er Slope (%)	N/A		
N/A	Gutter Lip Ht (in)	N/A	N/A	Gutte	er X Slope (%)	N/A		
N/A	Painted X Walk1?	No	N/A	Paint	ed X Walk2?	N/A		
	X Walk 1 Direction	To W		X Wa	lk 2 Direction	N/A		
N/A	X Walk 1 Width (in)	N/A	N/A	X Wa	ılk 2 Width (in)	N/A

X Walk 1 Slope (%)	2.7		X Wa	ılk 2 Slope (%)	N/A		
	X Walk 1 X Slope (%)	3.8		X Wa	ılk 2 X Slope (%)	N/A		
N/A	Ramp inside XWalk1?	N/A	N/A	Ram	p inside XWalk2?	N/A		
	Road Slope (%)	N/A	N/A	Clear	Space?	N/A		
	Road X Slope (%)	N/A	N/A	Clear	Space to XWalk (in)	N/A		
N/A	Any Obstructions?	N/A	N/A	Storn	n Grate/Utility Hazard?	N/A		
	Obstruction Type			Storn	n Grate/Utility Type			
		N/A				N/A		
			Yes	Surfa	ice Condition? (G/P)	Good		
140

Possible Solutions: Remove & Replace Entire Ramp. Surveyor Notes: N/A PROW/ADA: Not Found, R304.5.1, R304.2.2, R304.5.3
