# Access Compliance Report

## Public Rights-of-Way

### (Curb Ramps)

Intersection ID: 53893	Main Street: PERTH_MOOR_RD	Cross Street: HAMILTON_BRIDGE_RD	Location: NW
ADA ID: 403017F92A9E	Ramp Type: Perp	Initial Pass/Fail: Fail	Overall Compliance: No
Codes/Mitigation Info/Possible Solution		Field Measurements/Component Compliance	
Severity Score: 8.75

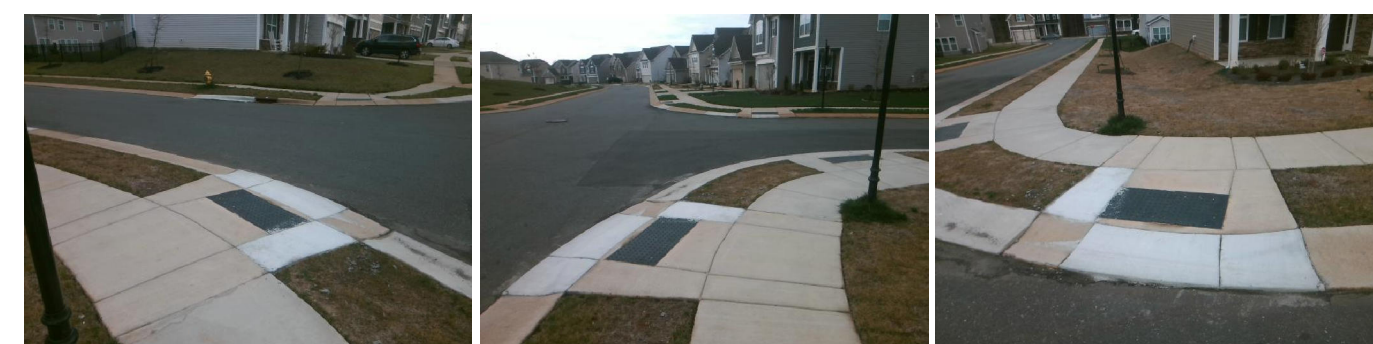
Possible Solutions:						
	Remove & Replace Entire Ramp.						
	Surveyor Notes:						
	N/A						
	PROW/ADA:						
	R304.5.1						
	Street 1 Name	HAMILTON BRIDGE RD					
	Stop Condition-Street 2	None					
	Street 2 Name	N/A					
	Stop Condition-Street 1	N/A					
Total Cost:		\$ 1850.00					
				Compliance	Description	Data	Compliance
				Description			Description
				Data			Data
				N/A	Ramp Length (in)	45.5	Yes
				No	Ramp Width (in)	47.0	Yes
				N/A	Flare Type LT	N/A	N/A
				N/A	Flare Slope LT (%)	N/A	N/A
				N/A	Flare Traversable LT?	N/A	N/A
				N/A	Flare Slope RT (%)	N/A	N/A
				N/A	Flare Traversable RT?	N/A	N/A
				N/A	Landing Length (in)	N/A	N/A
				N/A	Landing Width (in)	N/A	N/A
				N/A	Landing Slope (%)	N/A	N/A
				N/A	Landing X Slope (%)	N/A	N/A
				N/A	Landing Curb? (Y/N)	N/A	N/A
				N/A	Shared Landing?	N/A	N/A
				N/A	Gutter Ponding?	N/A	N/A
				N/A	Gutter Lip Ht (in)	2.0	N/A
				N/A	Painted X Walk1?	No	N/A

X Walk 1 Direction	To E	
				N/A	X Walk 1 Width (in)	N/A	N/A
					X Walk 1 Slope (%)	6.2	
					X Walk 1 X Slope (%)	1.0	
				N/A	Ramp inside XWalk1?	N/A	N/A
					Road Slope (%)	N/A	
					Road X Slope (%)	N/A	
				N/A	Any Obstructions?	N/A	N/A
					Obstruction Type		
						N/A	N/A
				Yes	Surface Condition? (G/P)		Good
