# Access Compliance Report

## Public Rights-of-Way

### (Curb Ramps)

Intersection ID: N/A	Main Street: CALDWELL_RD	Cross Street: OLD_STONE_CROSSING_DR	Location: SW
ADA ID: 4034899042EE	Ramp Type: Combination1Diag	Initial Pass/Fail: Fail	Overall Compliance: No
		Severity Score: 0

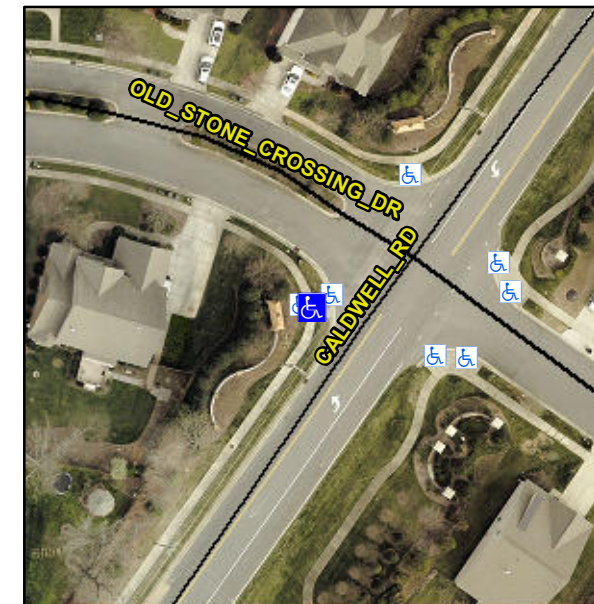
#### Field Measurements/Component Compliance

**Not Found, R304.5.1, R304.5.3, R304.3.2**

Compliance	Description	Data	Compliance	Description	Data
N/A	Ramp Length LT (in)	40.0	N/A	Ramp Length RT (in)	26.5
Yes	Ramp Width LT (in)	58.0	Yes	Ramp Width RT (in)	62.0
Yes	Ramp Slope LT (%)	6.8	No	Ramp Slope RT (%)	8.6
No	Ramp XSlope LT (%)	3.8	Yes	Ramp XSlope RT (%)	1.7
N/A	Ramp Length (in)	92.0	Yes	Ramp Slope (%)	5.0
No	Ramp Width (in)	46.0	No	Ramp XSlope (%)	6.6
N/A	Flare Type LT	N/A	N/A	Flare Type RT	N/A
N/A	Flare Slope LT (%)	N/A	N/A	Flare Slope RT (%)	N/A
N/A	Flare Traversable LT?	N/A	N/A	Flare Traversable RT?	N/A
N/A	Landing Length (in)	N/A	N/A	DWS Provided?	N/A
N/A	Landing Width (in)	N/A	N/A	DWS Contrast?	N/A
N/A	Landing Slope (%)	N/A	N/A	DWS Length (in)	N/A
N/A	Landing X Slope (%)	N/A	N/A	DWS Full Width?	N/A
N/A	Landing Curb? (Y/N)	N/A	N/A	DWS Offset (in)	N/A
N/A	Shared Landing?	N/A			
N/A	Gutter Ponding?	N/A	N/A	Gutter Slope (%)	N/A
N/A	Gutter Lip Ht (in)	N/A	N/A	Gutter X Slope (%)	N/A
N/A	Painted X Walk1?	No	N/A	Painted X Walk2?	No

X Walk 1 Direction	To SE		X Walk 2 Direction	To NE
	X Walk 1 Width (in)	N/A		X Walk 2 Width (in)	N/A
	X Walk 1 Slope (%)	7.3		X Walk 2 Slope (%)	3.8
	X Walk 1 X Slope (%)	1.0		X Walk 2 X Slope (%)	11.0
N/A	Ramp inside XWalk1?	N/A	N/A	Ramp inside XWalk2?	N/A
	Road Slope (%)	6.5		Clear Space?	N/A
	Road X Slope (%)	9.3	N/A	Clear Space to XWalk (in)	N/A
			N/A	Any Obstruction?	N/A
				Obstruction Type	N/A
			N/A	Storm Grate/Utility Hazard?	N/A
				Storm Grate/Utility Type	N/A
			Yes	Surface Condition? (G/P)	Good
				Curb Slope (%)	14.2

Possible Solutions:

**Remove & Replace Curb Ramp With Two New Directional Ramps or Equivalent.**

Total Cost: \$ 3200.00
