Access Compliance Report Public Rights-of-Way (Curb Ramps)

Intersection ID: 28395 Main Street: BRIDGEHAMPTON CLUB DR Cross Street: CHATSWORTH CT Location: NE

Ramp Type: BlendTrans2 Initial Pass/Fail: Fail **Overall Compliance: No** ADA ID: 4049A728AD30 **Severity Score:** 8.75

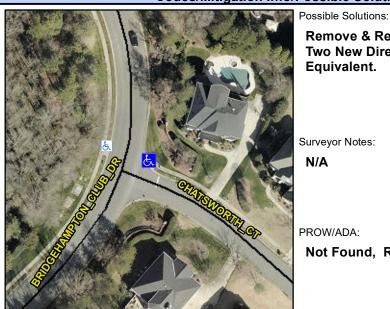
Not Found, R304.5.1

N/A	Ramp Length (in)	96.0	Yes	BlendTrans Slope (%)
No	Ramp Width (in)	38.5	Yes	BlendTrans XSlope (%)
N/A	Flare Type LT	N/A	N/A	Flare Type RT
N/A	Flare Slope LT (%)	N/A	N/A	Flare Slope RT (%)
N/A	Flare Traversable LT?	N/A	N/A	Flare Traversable RT?
N/A	Landing Length (in)	N/A	N/A	DWS Provided?
N/A	Landing Width (in)	N/A	N/A	DWS Contrast?
N/A	Landing Slope (%)	N/A	N/A	DWS Length (in)
N/A	Landing X Slope (%)	N/A	N/A	DWS Full Width?
N/A	Landing Curb? (Y/N)	N/A	N/A	DWS Offset (in)
N/A	Shared Landing?	N/A		
N/A	Gutter Ponding?	N/A	N/A	Gutter Slope (%)
N/A	Gutter Lip Ht (in)	N/A	N/A	Gutter X Slope (%)
N/A	Painted X Walk1?	No	N/A	Painted X Walk2?
	X Walk 1 Direction	To NW		X Walk 2 Direction
	X Walk 1 Width (in)	N/A		X Walk 2 Width (in)
	X Walk 1 Slope (%)	6.3		X Walk 2 Slope (%)
	X Walk 1 X Slope (%)	0.0		X Walk 2 X Slope (%)
N/A	Ramp inside XWalk1?	N/A	N/A	Ramp inside XWalk2?
	Road Slope (%)	0.0		Clear Space?
	Road X Slope (%)	6.3	N/A	Clear Space to XWalk (in)

Remove & Replace Curb Ramp With Two New Directional Ramps or Equivalent.
