# Access Compliance Report

## Public Rights-of-Way

### (Curb Ramps)

| Intersection ID: 31704 | Main Street: ATLAS_CEDAR_DR | Cross Street: DEODORA_CEDAR_LN | Location: SE |

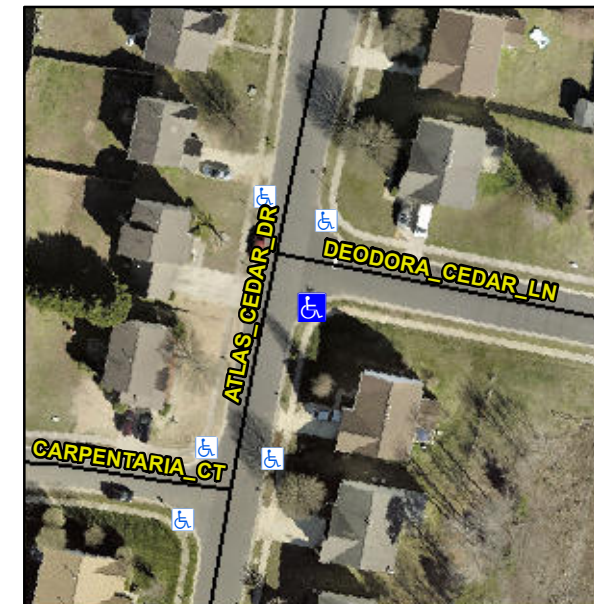
| ADA ID: 406A670AC6CE | Ramp Type: PerpDiag | Initial Pass/Fail: Fail | Overall Compliance: No |
| | | Severity Score: 10 | |

**Not Found, R304.5.1, R304.5.3**

| Compliance | Description | Data | Compliance | Description | Data |
|---|---|---|---|---|---|
| N/A | Ramp Length (in) | 47.0 | Yes | Ramp Slope (%) | 6.7 |
| No | Ramp Width (in) | 39.5 | No | Ramp XSlope (%) | 3.5 |

**Remove & Replace Curb Ramp With Two New Directional Ramps or Equivalent.**

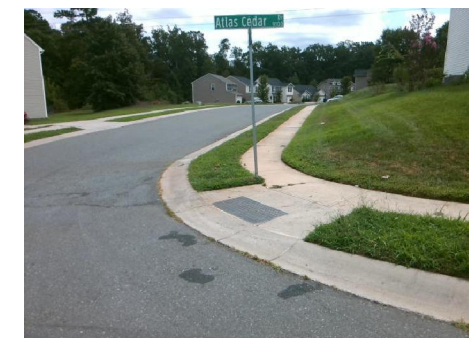
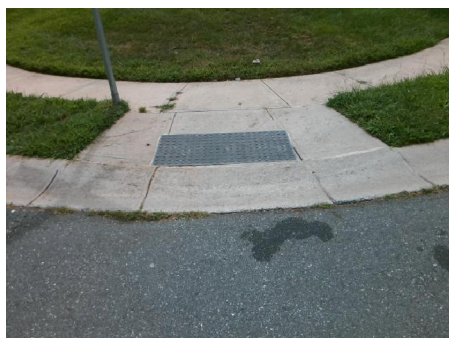
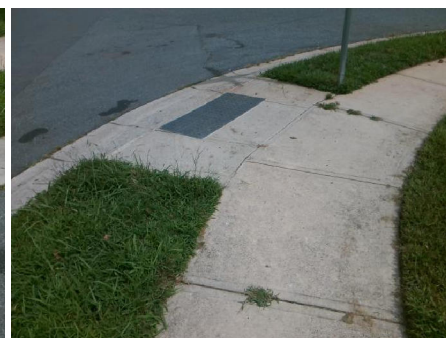
Street 1 Name **DEODORA CEDAR LN**  
 Stop Condition-Street 2 **StopSign**  
 Street 2 Name **ATLAS CEDAR DR**  
 Stop Condition-Street 1 **None**
