Access Compliance Report Public Rights-of-Way (Curb Ramps)

Intersection ID: 29422 Main Street: BRADSTREET_COMMONS_WYCross Street: SHINY_MEADOW_LN Location: SE

> Ramp Type: Perp **Codes/Mitigation Info/Possible Solution**

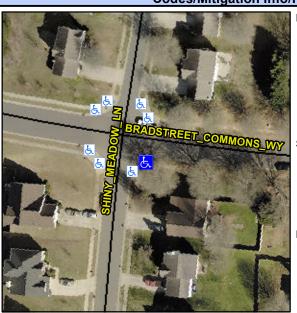
Possible Solutions:
Remove & Replace Entire Ramp.
Surveyor Notes:
N/A
PROW/ARA
PROW/ADA:
Not Found, R304.5.1, R304.2.2, R304.5.3
K304.5.3
•

Initial F	Pass/Fa	ail: Fail Overall	Complian	ce: No	Severity Score:	33.7					
Field Measurements/Component Compliance											
	Comp	liance Description	Data	Compl	liance Description	Data					
	N/A	Ramp Length (in)	48.0	No	Ramp Slope (%)	8.9					
	No	Ramp Width (in)	47.5	No	Ramp XSlope (%)	5.5					
	N/A	Flare Type LT	N/A	N/A	Flare Type RT	N/A					
	N/A	Flare Slope LT (%)	N/A	N/A	Flare Slope RT (%)	N/A					
	N/A	Flare Traversable LT?	N/A	N/A	Flare Traversable RT?	N/A					
	N/A	Landing Length (in)	N/A	N/A	DWS Provided?	N/A					
	N/A	Landing Width (in)	N/A	N/A	DWS Contrast?	N/A					
	N/A	Landing Slope (%)	N/A	N/A	DWS Length (in)	N/A					
	N/A	Landing X Slope (%)	N/A	N/A	DWS Full Width?	N/A					
	N/A	Landing Curb? (Y/N)	N/A	N/A	DWS Offset (in)	N/A					
	N/A	Shared Landing?	N/A								
	N/A	Gutter Ponding?	N/A	N/A	Gutter Slope (%)	N/A					
	N/A	Gutter Lip Ht (in)	N/A	N/A	Gutter X Slope (%)	N/A					
	N/A	Painted X Walk1?	No	N/A	Painted X Walk2?	N/A

X Walk 1 Direction	To N		X Walk 2 Direction	N/A					
	N/A	X Walk 1 Width (in)	N/A	N/A	X Walk 2 Width (in)	N/A					
		X Walk 1 Slope (%)	4.0		X Walk 2 Slope (%)	N/A					
		X Walk 1 X Slope (%)	6.7		X Walk 2 X Slope (%)	N/A					
	N/A	Ramp inside XWalk1?	N/A	N/A	Ramp inside XWalk2?	N/A					
		Road Slope (%)	N/A	N/A	Clear Space?	N/A					
		Road X Slope (%)	N/A	N/A	Clear Space to XWalk (in)	N/A					
	N/A	Any Obstructions?	N/A	N/A	Storm Grate/Utility Hazard?	N/A

850.00		Obstruction Type			Storm Grate/Utility Type						
			N/A			N/A					
				Yes	Surface Condition? (G/P)	Good
