Access Compliance Report

Public Rights-of-Way

(Curb Ramps)

Intersection ID: 19394	Main Street: DEANWOOD_PL	Cross Street: ECHODALE_DR	Location: NW
ADA ID: 4075C9BAB392	Ramp Type: Directional1	Initial Pass/Fail: Fail	Overall Compliance: No
		Severity Score: 25

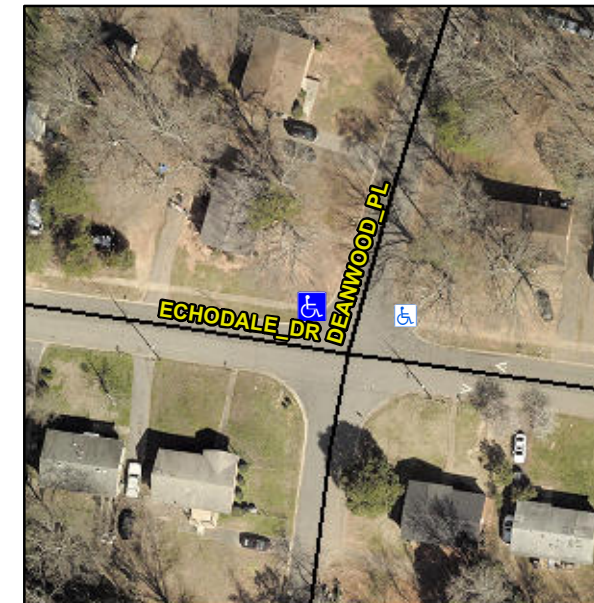
R304.5.3

Compliance	Description	Data	Compliance	Description	Data
N/A	Ramp Length (in)	48.0	N/A	Grade Break?	N/A
Yes	Ramp Width (in)	48.0	N/A	Grade Break Slope (%)	0.0
Yes	Ramp Slope (%)	2.6	N/A	Grade Break XSlope (%)	0.0
No	Ramp XSlope (%)	8.0			
N/A	Flare Type LT	N/A	N/A	Flare Type RT	N/A
N/A	Flare Slope LT (%)	N/A	N/A	Flare Slope RT (%)	0.0
N/A	Flare Traversable LT?	N/A	N/A	Flare Traversable RT?	N/A
N/A	Landing Length (in)	0.0	N/A	DWS Provided?	N/A
N/A	Landing Width (in)	0.0	N/A	DWS Contrast?	N/A
N/A	Landing Slope (%)	0.0	N/A	DWS Length (in)	N/A
N/A	Landing X Slope (%)	0.0	N/A	DWS Full Width?	N/A
N/A	Landing Curb? (Y/N)	N/A	N/A	DWS Offset LT (in)	N/A
N/A	Shared Landing?	N/A	N/A	DWS Offset RT (in)	N/A
N/A	Gutter Ponding?	0.0	N/A	Gutter Slope (%)	N/A
N/A	Gutter Lip Ht (in)	0.0	N/A	Gutter X Slope (%)	N/A
N/A	Painted X Walk1?	No		Road Slope (%)	7.4
	X Walk 1 Direction	To NE		Road X Slope (%)	2.3
	X Walk 1 Width (in)	N/A		Clear Space?	N/A

X Walk 1 Slope (%)	7.4	N/A	Clear Space to XWalk (in)	N/A
	X Walk 1 X Slope (%)	2.3	N/A	Storm Grate/Utility Hazard?	N/A
N/A	Ramp inside XWalk1?	N/A		Storm Grate/Utility Type	
N/A	Any Obstructions?	N/A			N/A
	Obstruction Type		Yes	Surface Condition? (G/P)	Good
			N/A	Curb Slope (%)	30.6

Remove & Replace Entire Ramp.

Total Cost: \$ 1600.00
