# Access Compliance Report

## Public Rights-of-Way

Intersection ID: 30544	Main Street: STONECROFT_PARK_DR	Cross Street: SUMMERHILL_RIDGE_DR	Location: NE
ADA ID: 408A940D81A3	Ramp Type: PerpDiag	Initial Pass/Fail: Fail	Overall Compliance: No
Severity Score: 12.5			
Codes/Mitigation Info/Possible Solution		Field Measurements/Component Compliance

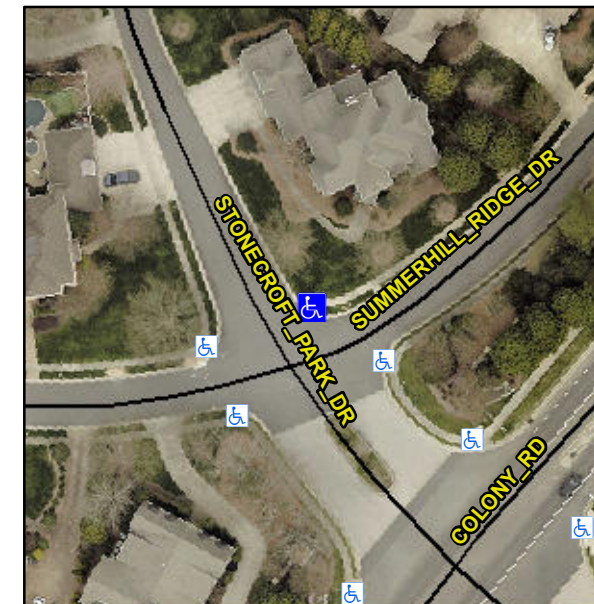
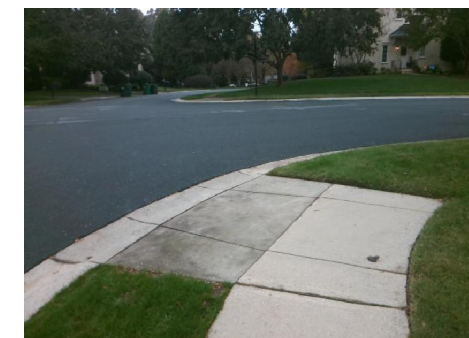
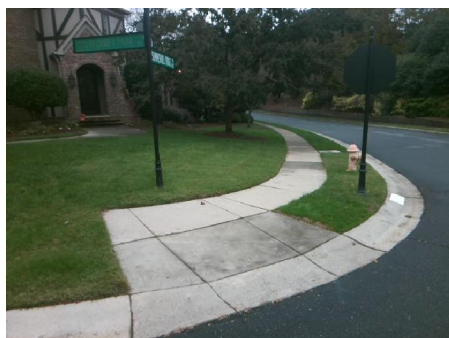
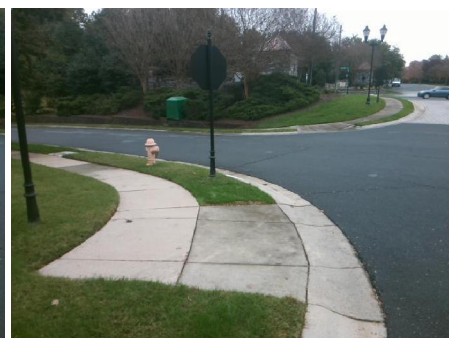
**Not Found, R304.5.3**

Compliance	Description	Data	Compliance	Description	Data
N/A	Ramp Length (in)	51.0	Yes	Ramp Slope (%)	5.0
Yes	Ramp Width (in)	48.0	No	Ramp XSlope (%)	5.2
N/A	Flare Type LT	N/A	N/A	Flare Type RT	N/A
N/A	Flare Slope LT (%)	N/A	N/A	Flare Slope RT (%)	N/A
N/A	Flare Traversable LT?	N/A	N/A	Flare Traversable RT?	N/A
N/A	Landing Length (in)	N/A	N/A	DWS Provided?	N/A
N/A	Landing Width (in)	N/A	N/A	DWS Contrast?	N/A
N/A	Landing Slope (%)	N/A	N/A	DWS Length (in)	N/A
N/A	Landing X Slope (%)	N/A	N/A	DWS Full Width?	N/A
N/A	Landing Curb? (Y/N)	N/A	N/A	DWS Offset (in)	N/A
N/A	Shared Landing?	N/A			
N/A	Gutter Ponding?	N/A	N/A	Gutter Slope (%)	N/A
N/A	Gutter Lip Ht (in)	N/A	N/A	Gutter X Slope (%)	N/A
N/A	Painted X Walk1?	No	N/A	Painted X Walk2?	No
	X Walk 1 Direction	To SW		X Walk 2 Direction	To SE
N/A	X Walk 1 Width (in)	N/A	N/A	X Walk 2 Width (in)	N/A
	X Walk 1 Slope (%)	2.1		X Walk 2 Slope (%)	1.0
	X Walk 1 X Slope (%)	2.0		X Walk 2 X Slope (%)	4.5

N/A	Ramp inside XWalk1?	N/A	N/A	Ramp inside XWalk2?	N/A
	Road Slope (%)	2.0	N/A	Clear Space?	N/A
	Road X Slope (%)	4.0	N/A	Clear Space to XWalk (in)	N/A
N/A	Any Obstructions?	N/A	N/A	Storm Grate/Utility Hazard?	N/A
	Obstruction Type			Storm Grate/Utility Type	
		N/A			N/A
		Yes		Surface Condition? (G/P)	Good

**Remove & Replace Curb Ramp With Two New Directional Ramps or Equivalent.**
