Access Compliance Report

Public Rights-of-Way

(Curb Ramps)

Intersection ID: 15776	Main Street: HERTFORD_RD	Cross Street: HOPEDALE_AV	Location: SE
ADA ID: 4093806DF699	Ramp Type: Directional	Initial Pass/Fail: Fail	Overall Compliance: No
Severity Score: 1.25			
Codes/Mitigation Info/Possible Solution		Field Measurements/Component Compliance

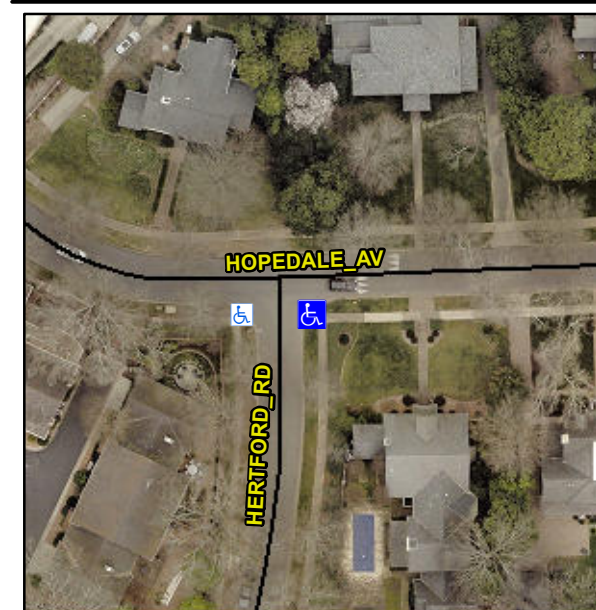
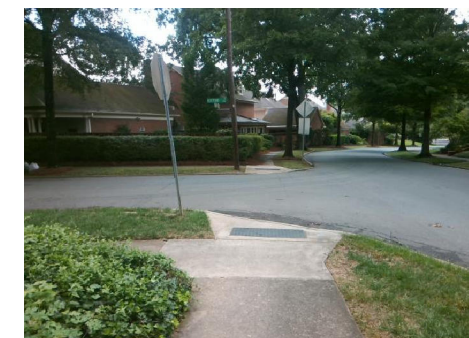
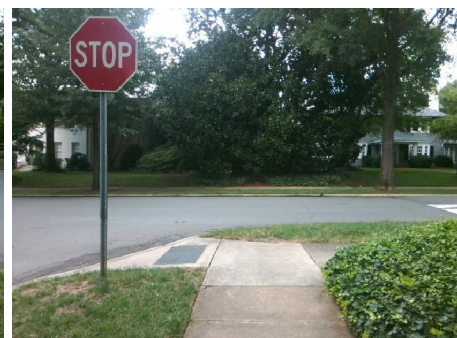
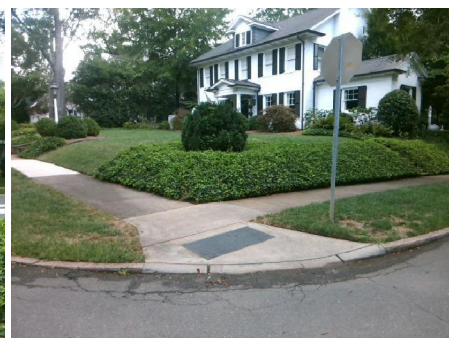
Compliance	Description	Data	Compliance	Description	Data
N/A	Ramp Length (in)	40.0	N/A	Grade Break?	N/A
Yes	Ramp Width (in)	48.0	N/A	Grade Break Slope (%)	0.0
Yes	Ramp Slope (%)	7.1	N/A	Grade Break XSlope (%)	0.0
No	Ramp XSlope (%)	2.6			
N/A	Flare Type LT	N/A	N/A	Flare Type RT	N/A
N/A	Flare Slope LT (%)	N/A	N/A	Flare Slope RT (%)	0.0
N/A	Flare Traversable LT?	N/A	N/A	Flare Traversable RT?	N/A
N/A	Landing Length (in)	0.0	N/A	DWS Provided?	N/A
N/A	Landing Width (in)	0.0	N/A	DWS Contrast?	N/A
N/A	Landing Slope (%)	0.0	N/A	DWS Length (in)	N/A
N/A	Landing X Slope (%)	0.0	N/A	DWS Full Width?	N/A
N/A	Landing Curb? (Y/N)	N/A	N/A	DWS Offset LT (in)	N/A
N/A	Shared Landing?	N/A	N/A	DWS Offset RT (in)	N/A
N/A	Gutter Ponding?	0.0	N/A	Gutter Slope (%)	N/A
N/A	Gutter Lip Ht (in)	0.0	N/A	Gutter X Slope (%)	N/A
N/A	Painted X Walk1?	No		Road Slope (%)	1.1
	X Walk 1 Direction	To SW		Road X Slope (%)	1.2
	X Walk 1 Width (in)	N/A		Clear Space?	N/A

X Walk 1 Slope (%)	1.1	N/A	Clear Space to XWalk (in)	N/A
	X Walk 1 X Slope (%)	1.2	N/A	Storm Grate/Utility Hazard?	N/A
N/A	Ramp inside XWalk1?	N/A		Storm Grate/Utility Type	
N/A	Any Obstructions?	N/A			N/A
	Obstruction Type		Yes	Surface Condition? (G/P)	Good
			N/A	Curb Slope (%)	14.4

Possible Solutions:

Remove & Replace Entire Ramp.

R304.5.3
