# Access Compliance Report

## Public Rights-of-Way

### (Curb Ramps)

Intersection ID: 15153	Main Street: GRIFFITH_ST	Cross Street: POINDEXTER_DR	Location:	N
ADA ID: 40BD154E8CDD	Ramp Type: Perp	Initial Pass/Fail: Fail	Overall Compliance: No	Severity Score: 12.5
Codes/Mitigation Info/Possible Solution		Field Measurements/Component Compliance

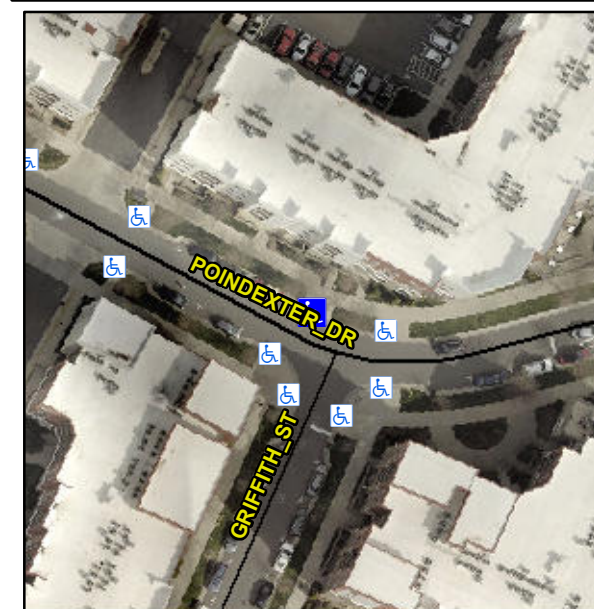
**Not Found, R304.2.2**

Compliance	Description	Data	Compliance	Description	Data
N/A	Ramp Length (in)	71.0	No	Ramp Slope (%)	10.1
Yes	Ramp Width (in)	48.0	Yes	Ramp XSlope (%)	0.2
N/A	Flare Type LT	N/A	N/A	Flare Type RT	N/A
N/A	Flare Slope LT (%)	N/A	N/A	Flare Slope RT (%)	N/A
N/A	Flare Traversable LT?	N/A	N/A	Flare Traversable RT?	N/A
N/A	Landing Length (in)	N/A	N/A	DWS Provided?	N/A
N/A	Landing Width (in)	N/A	N/A	DWS Contrast?	N/A
N/A	Landing Slope (%)	N/A	N/A	DWS Length (in)	N/A
N/A	Landing X Slope (%)	N/A	N/A	DWS Full Width?	N/A
N/A	Landing Curb? (Y/N)	N/A	N/A	DWS Offset (in)	N/A
N/A	Shared Landing?	N/A			
N/A	Gutter Ponding?	N/A	N/A	Gutter Slope (%)	N/A
N/A	Gutter Lip Ht (in)	N/A	N/A	Gutter X Slope (%)	N/A
N/A	Painted X Walk1?	No	N/A	Painted X Walk2?	N/A
	X Walk 1 Direction	To SW		X Walk 2 Direction	N/A
N/A	X Walk 1 Width (in)	N/A	N/A	X Walk 2 Width (in)	N/A
	X Walk 1 Slope (%)	1.9		X Walk 2 Slope (%)	N/A
	X Walk 1 X Slope (%)	0.9		X Walk 2 X Slope (%)	N/A

N/A	Ramp inside XWalk1?	N/A	N/A	Ramp inside XWalk2?	N/A
	Road Slope (%)	N/A	N/A	Clear Space?	N/A
	Road X Slope (%)	N/A	N/A	Clear Space to XWalk (in)	N/A
N/A	Any Obstructions?	N/A	N/A	Storm Grate/Utility Hazard?	N/A
	Obstruction Type			Storm Grate/Utility Type	
		N/A			N/A
			Yes	Surface Condition? (G/P)	Good

**Remove & Replace Entire Ramp.**
