Intersection ID: 10036062	Main Street: RIVERGATE_PY	Cross Street: N/A	Location:	SW
ADA ID: 40C2AECD36EB	Ramp Type: Perp	Initial Pass/Fail: Fail	Overall Compliance: No	Severity Score: 12.5

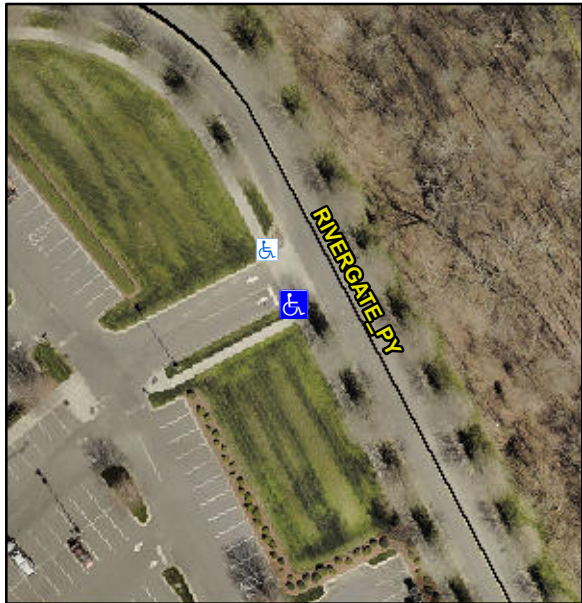
Possible Solutions:		Compliance	Description	Data	Compliance	Description	Data
	Remove & Replace Entire Ramp.		N/A	Ramp Length (in)	72.0	No	Ramp Slope (%)	8.7
			Yes	Ramp Width (in)	72.0	Yes	Ramp XSlope (%)	1.1
			N/A	Flare Type LT	N/A	N/A	Flare Type RT	N/A
			N/A	Flare Slope LT (%)	N/A	N/A	Flare Slope RT (%)	N/A
			N/A	Flare Traversable LT?	N/A	N/A	Flare Traversable RT?	N/A
			N/A	Landing Length (in)	N/A	N/A	DWS Provided?	N/A
	Surveyor Notes:		N/A	Landing Width (in)	N/A	N/A	DWS Contrast?	N/A
	N/A		N/A	Landing Slope (%)	N/A	N/A	DWS Length (in)	N/A
			N/A	Landing X Slope (%)	N/A	N/A	DWS Full Width?	N/A
			N/A	Landing Curb? (Y/N)	N/A	N/A	DWS Offset (in)	N/A
			N/A	Shared Landing?	N/A			
			N/A	Gutter Ponding?	N/A	N/A	Gutter Slope (%)	N/A
			N/A	Gutter Lip Ht (in)	N/A	N/A	Gutter X Slope (%)	N/A
	PROW/ADA:		N/A	Painted X Walk1?	No	N/A	Painted X Walk2?	N/A

Not Found, R304.2.2			X Walk 1 Direction	To NW		X Walk 2 Direction	N/A
			N/A	X Walk 1 Width (in)	N/A	N/A	X Walk 2 Width (in)	N/A
				X Walk 1 Slope (%)	0.5		X Walk 2 Slope (%)	N/A
				X Walk 1 X Slope (%)	4.1		X Walk 2 X Slope (%)	N/A
			N/A	Ramp inside XWalk1?	N/A	N/A	Ramp inside XWalk2?	N/A
				Road Slope (%)	N/A	N/A	Clear Space?	N/A
				Road X Slope (%)	N/A	N/A	Clear Space to XWalk (in)	N/A
			N/A	Any Obstructions?	N/A	N/A	Storm Grate/Utility Hazard?	N/A
	Total Cost:	\$ 1850.00		Obstruction Type			Storm Grate/Utility Type	
					N/A			N/A
						Yes	Surface Condition? (G/P)	Good
