Access Compliance Report

Public Rights-of-Way

(Curb Ramps)

Intersection ID: 27411	Main Street: BALLANTYNE COMMONS PY	Cross Street: BALLANTYNE CORPORATE PL	Location: NE
ADA ID: 40D9648A5A50	Ramp Type: Perp	Initial Pass/Fail: Fail	Overall Compliance: No
Severity Score: 13.75			
Codes/Mitigation Info/Possible Solution		Field Measurements/Component Compliance

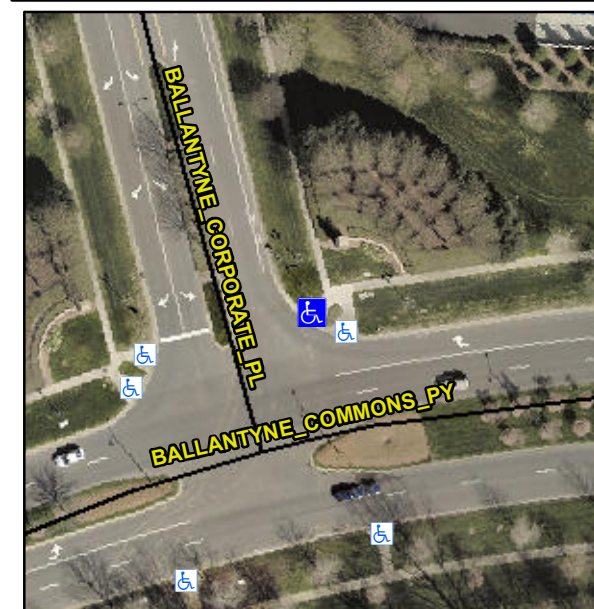
Not Found, R304.2.2, R304.5.3

Compliance	Description	Data	Compliance	Description	Data
N/A	Ramp Length (in)	117.0	No	Ramp Slope (%)	9.0
Yes	Ramp Width (in)	50.0	No	Ramp XSlope (%)	3.9
N/A	Flare Type LT	N/A	N/A	Flare Type RT	N/A
N/A	Flare Slope LT (%)	N/A	N/A	Flare Slope RT (%)	N/A
N/A	Flare Traversable LT?	N/A	N/A	Flare Traversable RT?	N/A
N/A	Landing Length (in)	N/A	N/A	DWS Provided?	N/A
N/A	Landing Width (in)	N/A	N/A	DWS Contrast?	N/A
N/A	Landing Slope (%)	N/A	N/A	DWS Length (in)	N/A
N/A	Landing X Slope (%)	N/A	N/A	DWS Full Width?	N/A
N/A	Landing Curb? (Y/N)	N/A	N/A	DWS Offset (in)	N/A
N/A	Shared Landing?	N/A			
N/A	Gutter Ponding?	N/A	N/A	Gutter Slope (%)	N/A
N/A	Gutter Lip Ht (in)	N/A	N/A	Gutter X Slope (%)	N/A
N/A	Painted X Walk1?	No	N/A	Painted X Walk2?	N/A
	X Walk 1 Direction	To W		X Walk 2 Direction	N/A
N/A	X Walk 1 Width (in)	N/A	N/A	X Walk 2 Width (in)	N/A
	X Walk 1 Slope (%)	1.0		X Walk 2 Slope (%)	N/A
	X Walk 1 X Slope (%)	0.5		X Walk 2 X Slope (%)	N/A

N/A	Ramp inside XWalk1?	N/A	N/A	Ramp inside XWalk2?	N/A
	Road Slope (%)	N/A	N/A	Clear Space?	N/A
	Road X Slope (%)	N/A	N/A	Clear Space to XWalk (in)	N/A
N/A	Any Obstructions?	N/A	N/A	Storm Grate/Utility Hazard?	N/A
	Obstruction Type			Storm Grate/Utility Type	
		N/A			N/A
			Yes	Surface Condition? (G/P)	Good

Possible Solutions:

Remove & Replace Entire Ramp.
