Intersection ID: 24124	Main Street: DEHAVILLAND_DR	Cross Street: PILCHER_DR	Location:	SW
ADA ID: 40EC04B6105F	Ramp Type: PerpDiag	Initial Pass/Fail: Fail	Overall Compliance: No	Severity Score: 12.5

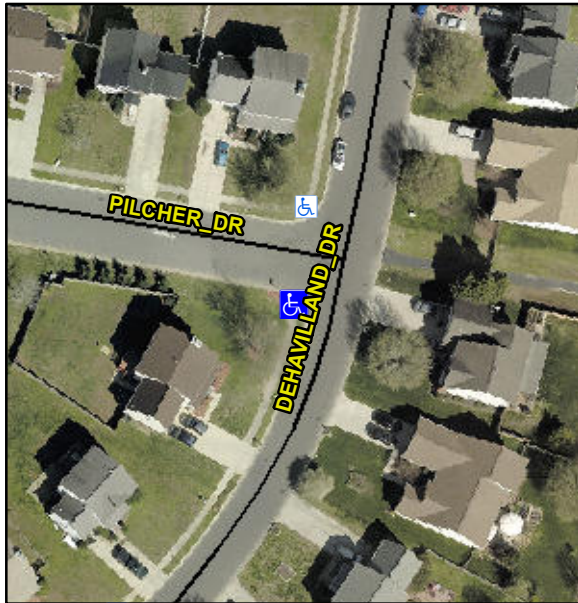
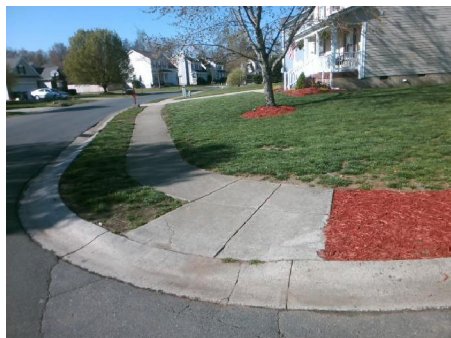
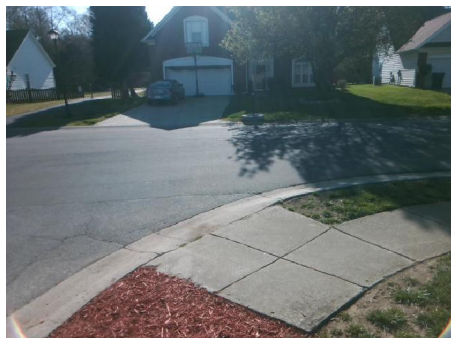
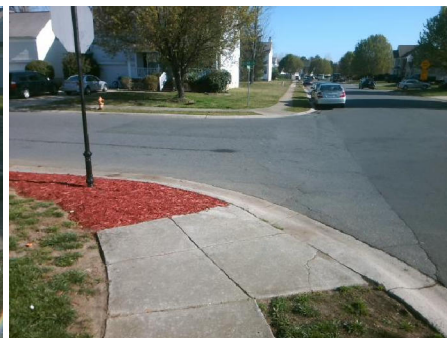
R304.2.2

Compliance	Description	Data	Compliance	Description	Data
N/A	Ramp Length (in)	89.0	No	Ramp Slope (%)	9.5
Yes	Ramp Width (in)	65.0	Yes	Ramp XSlope (%)	0.4
N/A	Flare Type LT	N/A	N/A	Flare Type RT	N/A
N/A	Flare Slope LT (%)	N/A	N/A	Flare Slope RT (%)	N/A
N/A	Flare Traversable LT?	N/A	N/A	Flare Traversable RT?	N/A
N/A	Landing Length (in)	N/A	N/A	DWS Provided?	N/A
N/A	Landing Width (in)	N/A	N/A	DWS Contrast?	N/A
N/A	Landing Slope (%)	N/A	N/A	DWS Length (in)	N/A
N/A	Landing X Slope (%)	N/A	N/A	DWS Full Width?	N/A
N/A	Landing Curb? (Y/N)	N/A	N/A	DWS Offset (in)	N/A
N/A	Shared Landing?	N/A			
N/A	Gutter Ponding?	N/A	N/A	Gutter Slope (%)	N/A
N/A	Gutter Lip Ht (in)	N/A	N/A	Gutter X Slope (%)	N/A
N/A	Painted X Walk1?	No	N/A	Painted X Walk2?	No
	X Walk 1 Direction	To SE		X Walk 2 Direction	To NE
N/A	X Walk 1 Width (in)	N/A	N/A	X Walk 2 Width (in)	N/A
	X Walk 1 Slope (%)	2.6		X Walk 2 Slope (%)	0.6
	X Walk 1 X Slope (%)	0.6		X Walk 2 X Slope (%)	0.6

N/A	Ramp inside XWalk1?	N/A	N/A	Ramp inside XWalk2?	N/A
	Road Slope (%)	1.7	N/A	Clear Space?	N/A
	Road X Slope (%)	2.0	N/A	Clear Space to XWalk (in)	N/A
N/A	Any Obstructions?	N/A	N/A	Storm Grate/Utility Hazard?	N/A
	Obstruction Type			Storm Grate/Utility Type	
		N/A			N/A
			Yes	Surface Condition? (G/P)	Good

Remove & Replace Curb Ramp With Two New Directional Ramps or Equivalent.

Total Cost: \$ 3200.00
