N/A

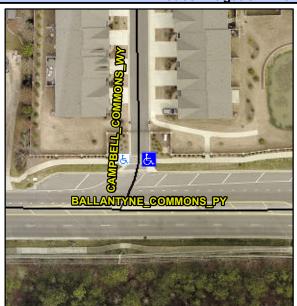
CAMPBELL COMMONS WY Street 1 Name Stop Condition-Street 1 StopSign Street 2 Name N/A Stop Condition-Street 2 N/A

/Possible Solution		Field Measurements/Component Compliance				
Possible Solutions:		Compliance Description			Comp	liance Description
Remove & Replace Entire	Ramp.	N/A	Ramp Length (in)	133.0	N/A	Grade Break?

•	Yes	Ramp Width (in)	71.0	N/A	Grade Break Slope (%)
		Yes	Ramp Slope (%)	7.7	N/A	Grade Break XSlope (%)
		No	Ramp XSlope (%)	2.3		
		N/A	Flare Type LT	N/A	N/A	Flare Type RT
		N/A	Flare Slope LT (%)	N/A	N/A	Flare Slope RT (%)
Surveyor Notes:		N/A	Flare Traversable LT?	N/A	N/A	Flare Traversable RT?
NO CURB LINE		N/A	Landing Length (in)	0.0	N/A	DWS Provided?
2		N/A	Landing Width (in)	0.0	N/A	DWS Contrast?
		N/A	Landing Slope (%)	0.0	N/A	DWS Length (in)
		N/A	Landing X Slope (%)	0.0	N/A	DWS Full Width?
PROW/ADA:		N/A	Landing Curb? (Y/N)	N/A	N/A	DWS Offset LT (in)
R304.5.3		N/A	Shared Landing?	N/A	N/A	DWS Offset RT (in)
		N/A	Gutter Ponding?	0.0	N/A	Gutter Slope (%)
		N/A	Gutter Lip Ht (in)	0.0	N/A	Gutter X Slope (%)
		N/A	Painted X Walk1?	Yes		Road Slope (%)
			X Walk 1 Direction	To SW		Road X Slope (%)
			X Walk 1 Width (in)	91.5		Clear Space?
			X Walk 1 Slope (%)	0.6	N/A	Clear Space to XWalk (in)
			X Walk 1 X Slope (%)	4.4	N/A	Storm Grate/Utility Hazard?
