# Access Compliance Report

## Public Rights-of-Way

### (Curb Ramps)

| Intersection ID: 14064 | Main Street: E_PARK_AV | Cross Street: EUCLID_AV | Location: S |

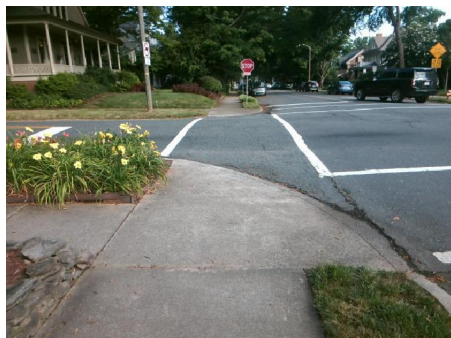
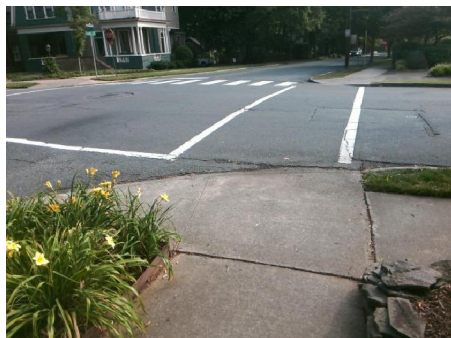
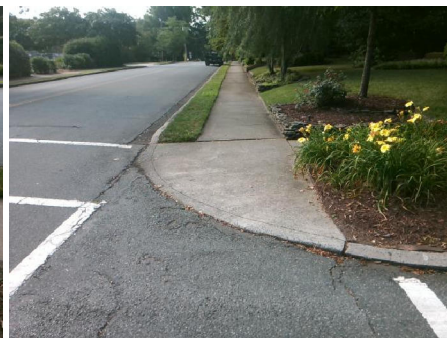
| ADA ID: 40F6A2ED1BB9 | Ramp Type: PerpDiag | Initial Pass/Fail: Pass | Overall Compliance: No |

**R304.5.3, R304.2.1, R304.2.2-Perp, R304.3.2-Para, Not Found, R305, R302.7, R302.7.2**

| Compliance | Description | Data | Compliance | Description | Data |
|---|---|---|---|---|---|
| Yes | Ramp Width (in) | 92.0 | No | Ramp XSlope (%) | 3.3 |
| No | Landing Length (in) | N/A | No | DWS Provided? | No |
| No | Gutter Ponding? | Yes | Yes | Gutter Slope (%) | 3.1 |
| No | Gutter Lip Ht (in) | 1.0 | No | Gutter X Slope (%) | 2.3 |
| | Road X Slope (%) | 2.8 | No | Clear Space to XWalk (in) | 28.0 |

**Remove & Replace Curb Ramp With Two New Directional Ramps or Equivalent. Restripe Crosswalk(s) To Provide Clear space. Remove & Replace Gutter.**
